Analysis of Building Damage during the 8 October 2005 Earthquake in Pakistan

S. T. Maqsood and J. Schwarz
Bauhaus Universität Weimar, Germany

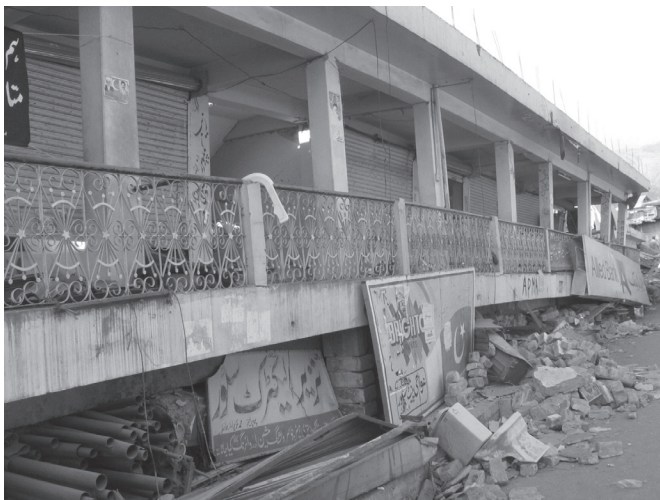
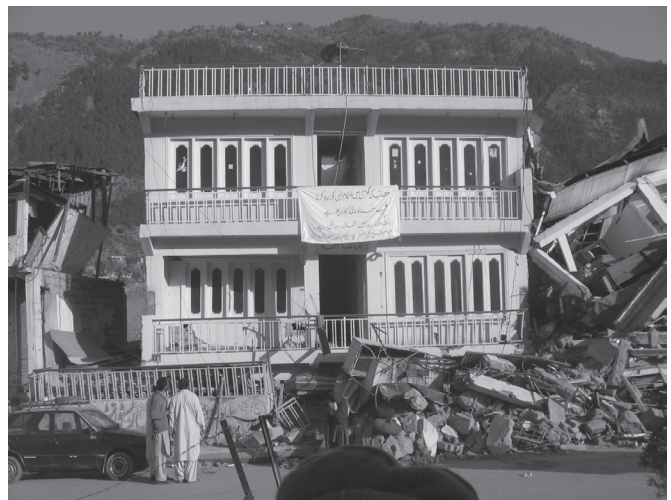
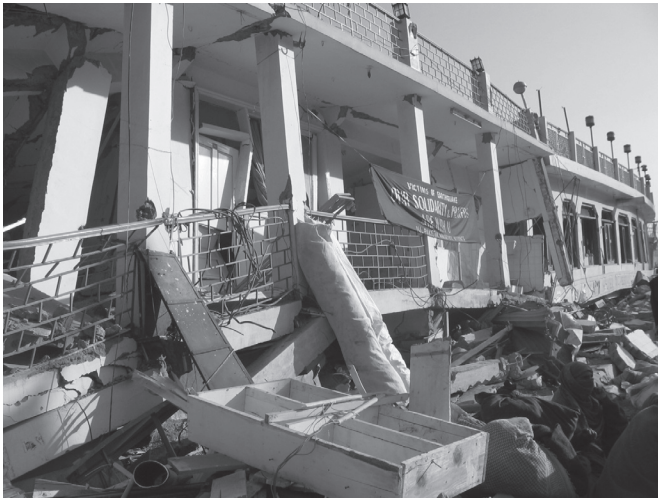
Many hotels and an entire string of shopping plazas along the main road of Balakot collapsed or suffered severe damage due to soft-story effect (see figures 8, 9, and 10). It is obvious from the failure mechanisms that these buildings were designed primarily for gravity loads with no consideration for lateral forces. The ground floor was used as shops without infill walls, thus creating a soft-story effect that led to the failure.

▲ **Figure 8.** Soft-story effect (Blk).

▲ **Figure 9.** Soft-story effect (Blk).

▲ **Figure 10.** Soft-story effect (Blk).

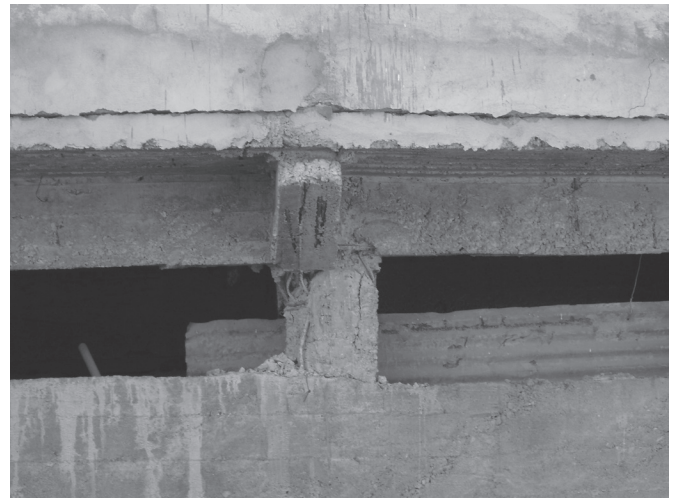
Lack of knowledge of engineering design was seen in the field trip. Figure 11 shows that the short-column effect (*i.e.*, the column fails by shearing) and the lack of seismic consideration resulted in the failure of many columns in cities such as Muzaffarabad and Balakot.

▲ **Figure 11.** Short-column effect (Blk).

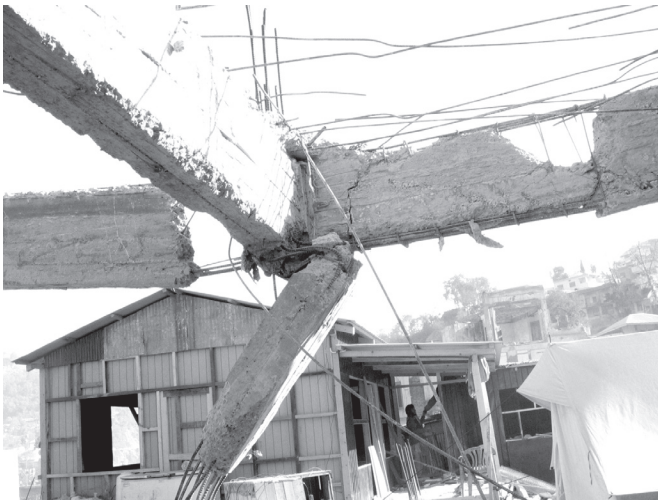
▲ **Figure 12.** Strong beam–weak column (Blk).

Many structures suffered severe damage because of the strong beam–weak column phenomenon. These weak columns (see figure 12) were not able to sustain the horizontal earthquake loading and failed, resulting in the collapse of the structure.

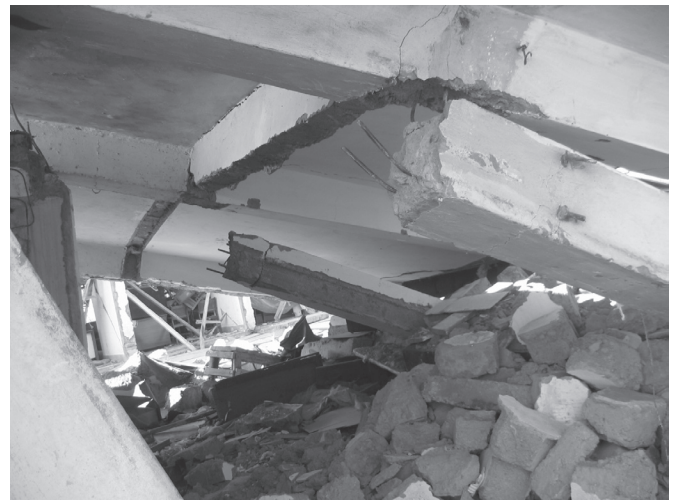
▲ **Figure 13.** Anchorage and development length (Blk).

Figure 13 shows the failure of a beam column joint due to insufficient development length, which resulted in the collapse of the structure: the length of the embedment of the steel bar should be enough to develop the full tensile strength, controlled either by pullout or splitting.

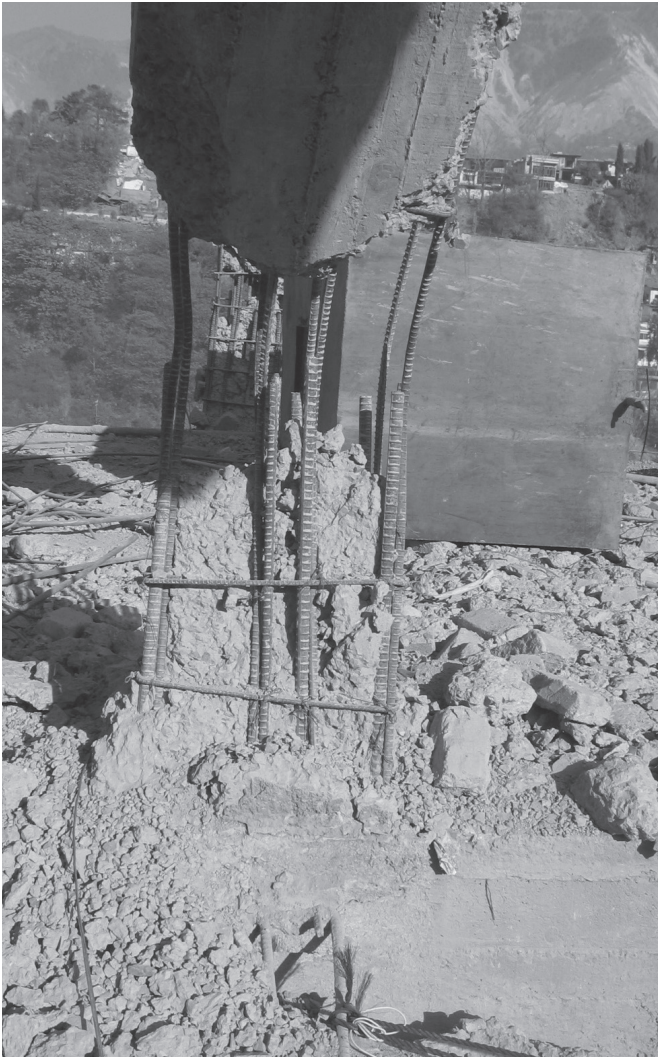
Some of the failures were directly caused by improper lateral confinement provided by insufficient shear reinforcement or

ties. The spacing of the ties did not satisfy even the gravity-load requirements. Figure 14 shows the spacing of the lateral ties at the bottom of the column, which were completely absent afterward.

▲ **Figure 14.** Lateral confinement of concrete (Blk).

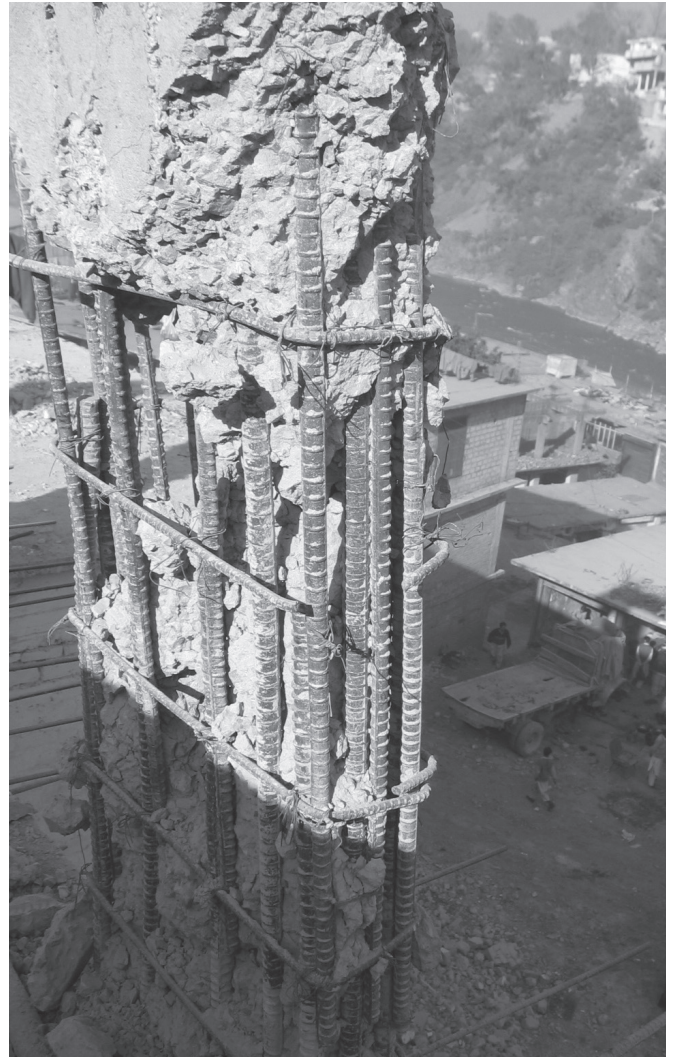
Bar splices have to be provided to join two steel bars. These splices should be provided at a location of low stress. However, as shown in figure 15, the lap splices were provided at the bottom of the column, where there is always a high resistance demand; also the lap splice length was found to be inadequate.

▲ **Figure 15.** Location of lap splice (Blk).

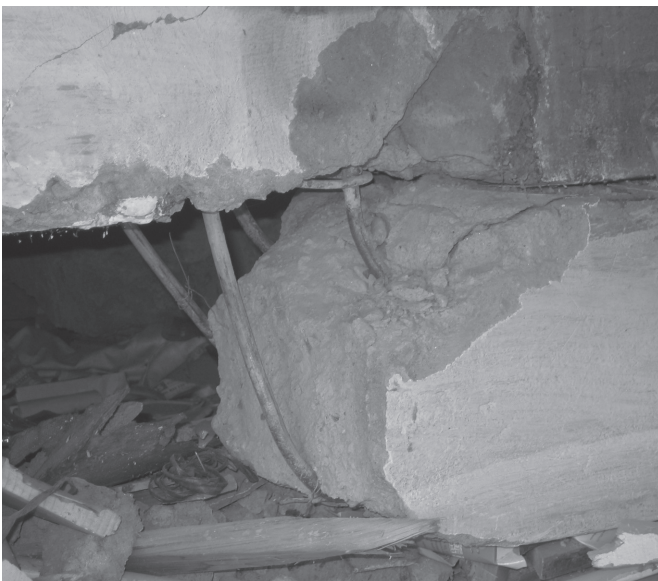
The failure of beam column joints also resulted from the bond failure of concrete and the steel reinforcement because of the use of smooth reinforcing bars (figure 16).

▲ **Figure 16.** Smooth reinforcing steel bars (Blk).

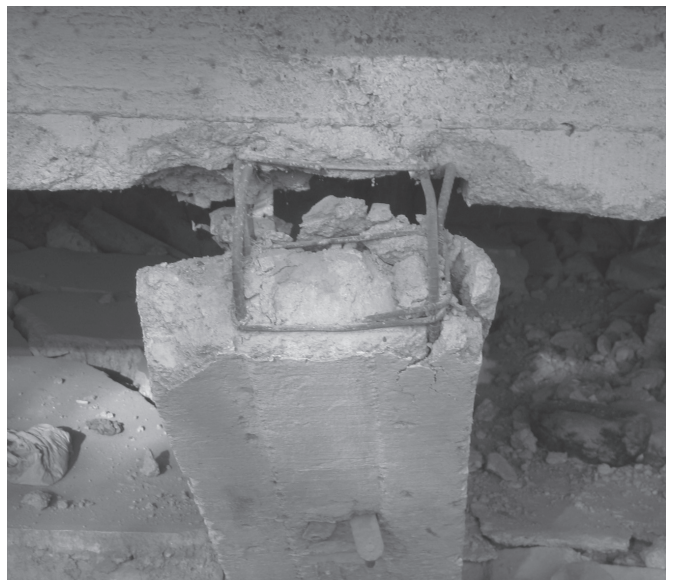
▲ **Figure 17.** Detailing of reinforcement (Blk).

Improper and deficient detailing was also a key factor in the collapse of many structures (figure 17). The building also highlights the poor quality control on the part of building officials.

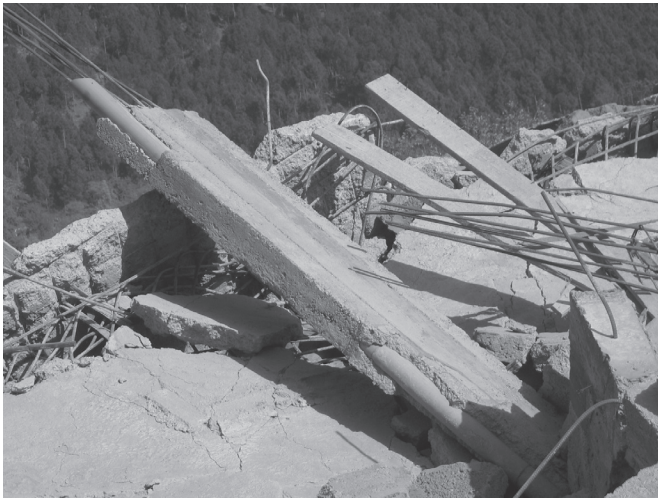
Public awareness of construction practices was found to be poor. The use of large PVC pipe for drainage inside a concrete column reduced its strength to a large extent, which resulted in its failure (figure 18).

▲ Figure 18. Construction practices (Blk).

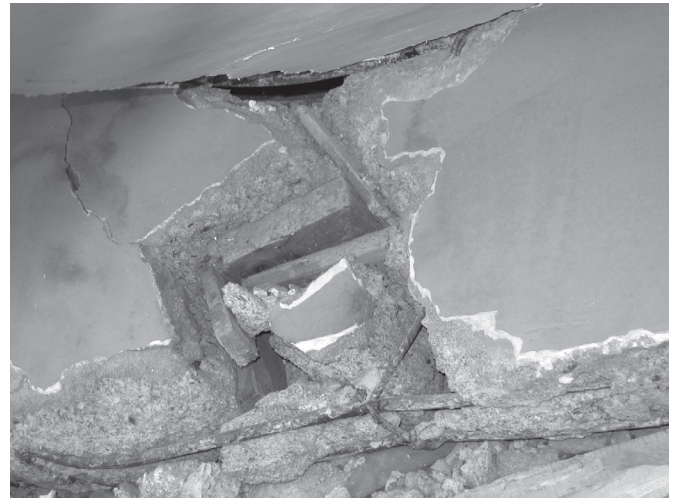
Poor workmanship was also a key factor in the damage of many structures. A wooden plank was left inside the concrete beam (figure 19), which made this section weaker; the beam in this section collapsed. There was no inspection carried out during or after the construction, which allowed the builders to use low-quality material.

▲ Figure 19. Workmanship (Blk).

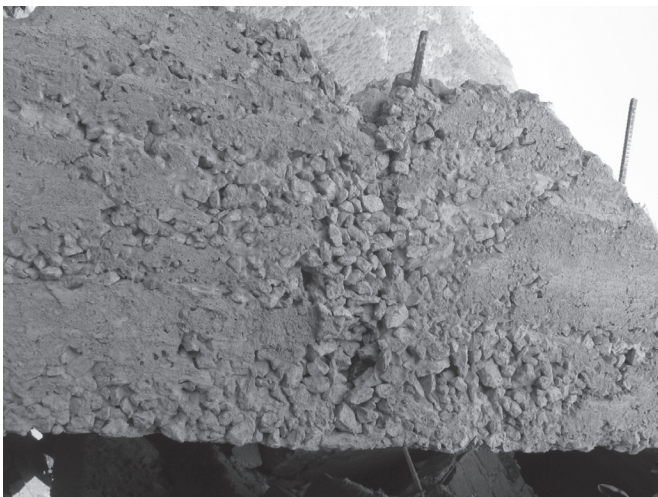
The nature of the damage indicates poor-quality construction, as shown in figure 20. Pouring and compaction of the concrete was not done properly, thus leaving honeycombing and voids in the hardened state of a beam.

▲ Figure 20. Quality of concrete (Blk).

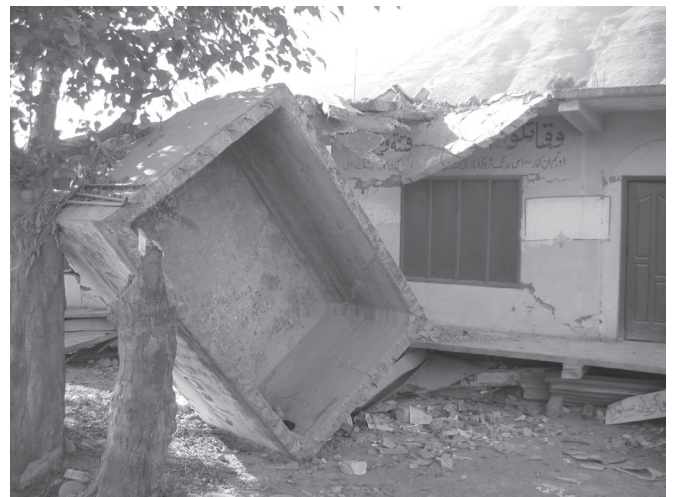
Large water tanks on the roof (figure 21) attracted high inertial forces. The water tank was not adequately anchored to the roof, which caused it to fall to the ground.

▲ Figure 21. Large water tanks at roof (Muz).

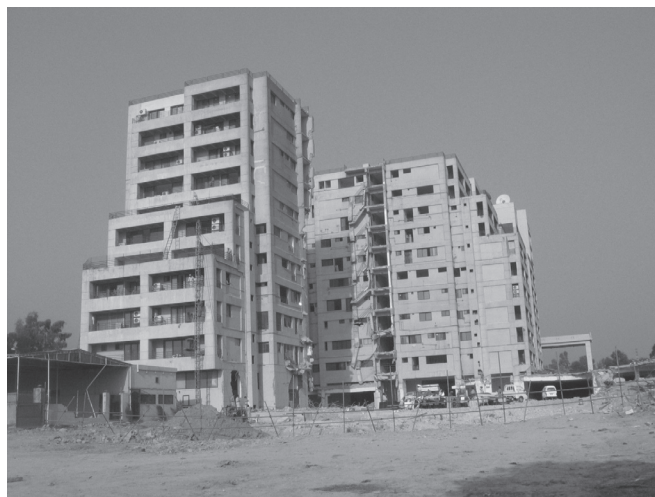
In Islamabad (Isb), 100 km away from the epicenter, the only structure that collapsed due to the shaking of the earthquake was a multistory residential apartment building, the Margalla Towers (figure 22).

About 100 people died due to the collapse of three of the building's 10 units. Each unit had 10 stories and a basement that was used as parking area. Each unit had concrete floors, which rested on concrete beams and columns. The infill masonry walls in the remaining standing units had numerous in-plane shear cracks. The maintenance of the buildings was poor. The basements suffered from severe seepage problems as shown in figure 23.

The units that remained standing did not suffer major structural damage, which suggests that either structural detailing was different in the failed units or these units were defective because of low-quality construction. The collapsed units were built in the final phase of construction.

▲ Figure 22. Margalla Towers (Isb).

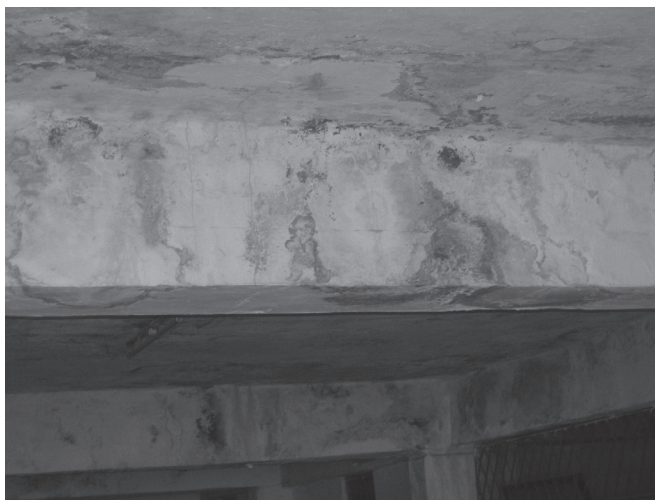
▲ Figure 23. Seepage and maintenance problem (Isb).

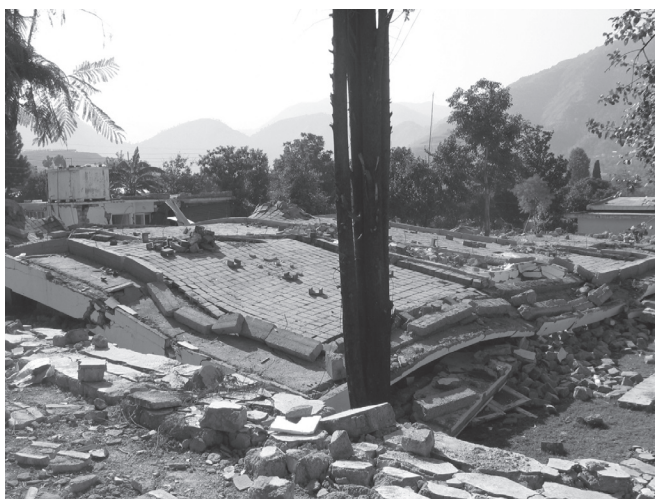
The main cause of collapse of masonry structures was the heavy weight of the roof, which attracted large inertial forces (figure 24). The slender unreinforced walls, without adequate connectivity to the roof, were not able to withstand these inertial forces.

▲ Figure 24. Heavy roof (Muz).

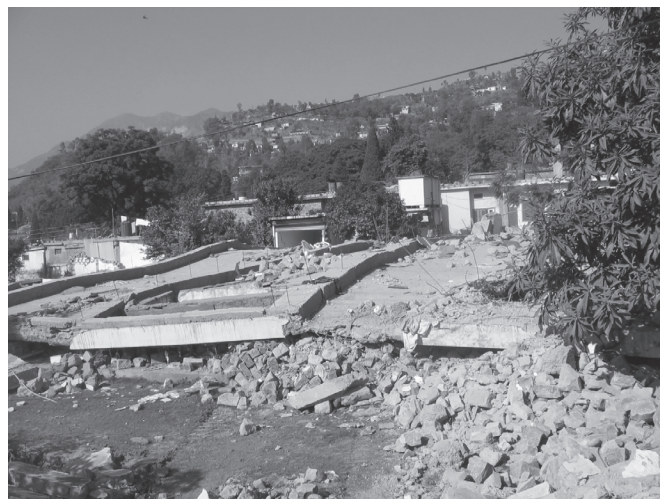
The heavy weight of the roof and the high inertial forces resulted in out-of-plane failure of the slender walls (figure 25).

Inadequate wall thickness and height resulted in slender walls which were not able to sustain the shaking of the earthquake.

▲ Figure 25. Out-of-plane failure (Muz).

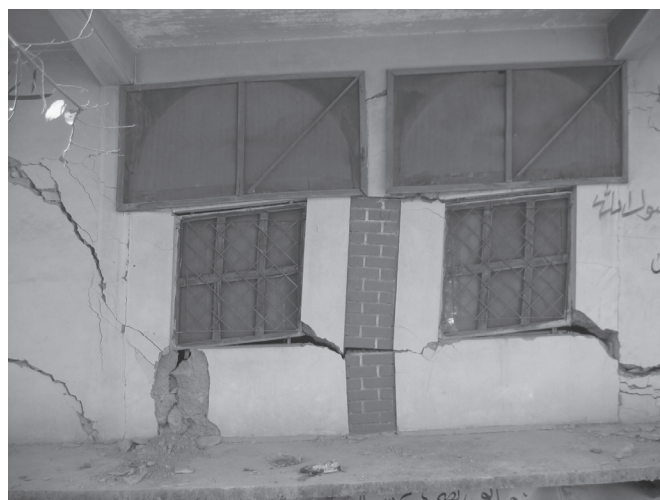
There was no vertical element of concrete or wood to resist the horizontal forces, and the cracks ran throughout the wall without any resistance (figure 26).

Relatively big openings in the walls also contributed to the damage (see figures 26 and 27).

▲ Figure 26. Shear cracks (Muz).

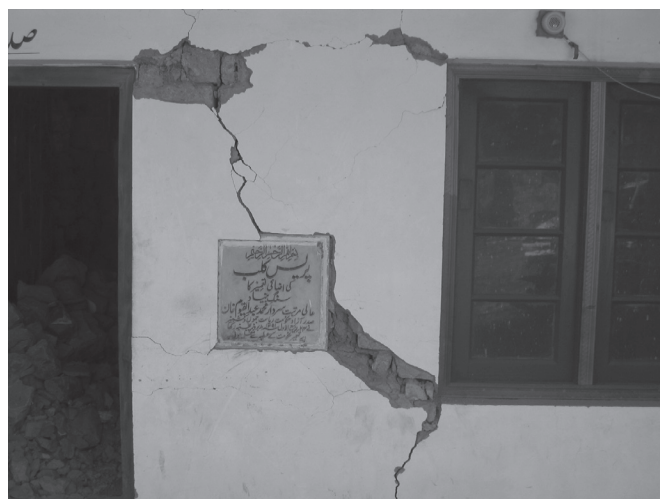
▲ Figure 27. Large openings (Muz).
