Analysis of Building Damage during the 8 October 2005 Earthquake in Pakistan

S. T. Maqsood and J. Schwarz
Bauhaus Universität Weimar, Germany

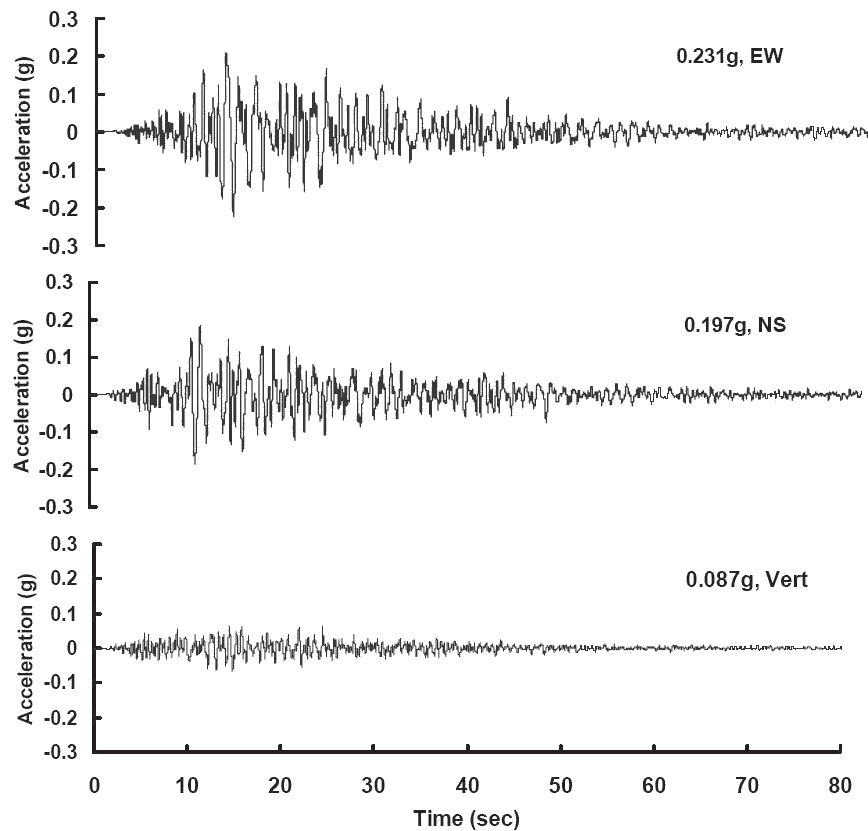
▲ **Figure 4.** Recording of main shock at Abbottabad recording station, 35 km, see figure 1, taken from Durani *et al.* 2005.

recording station is shown in figure 4. The 5% elastic spectrum shows a relatively broad range of high amplification, from 0.4 to 1.5 seconds for the EW direction of strong-motion recording at the Abbottabad station.

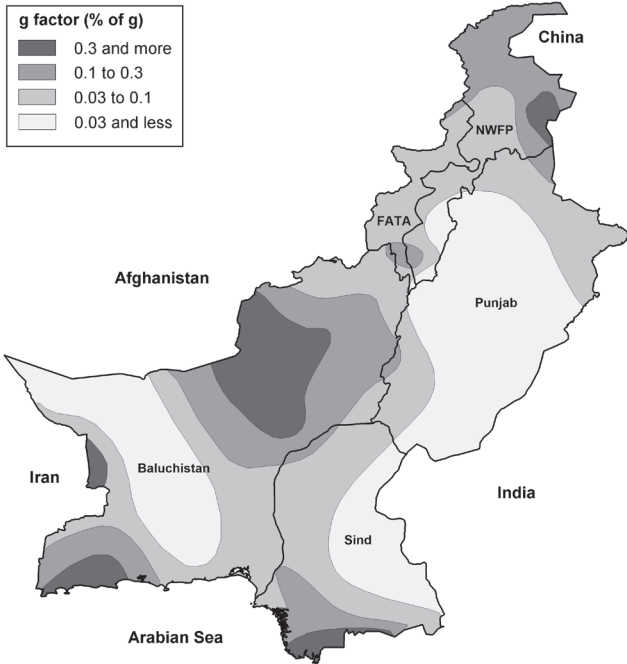
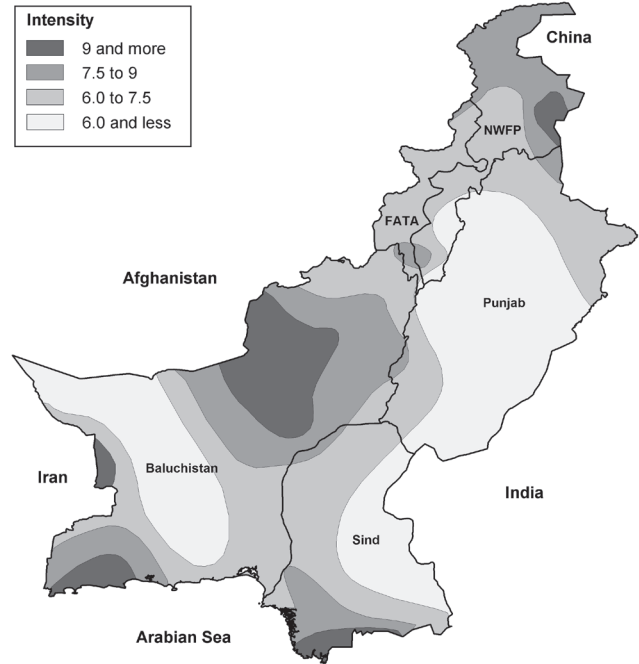
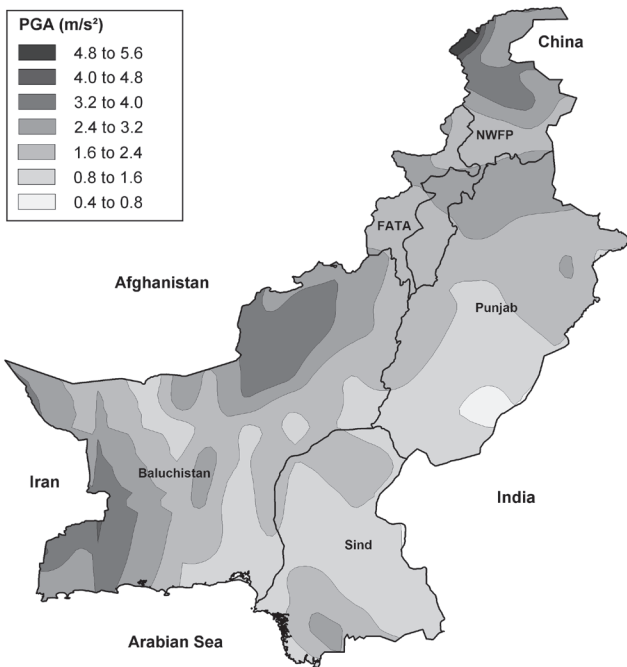
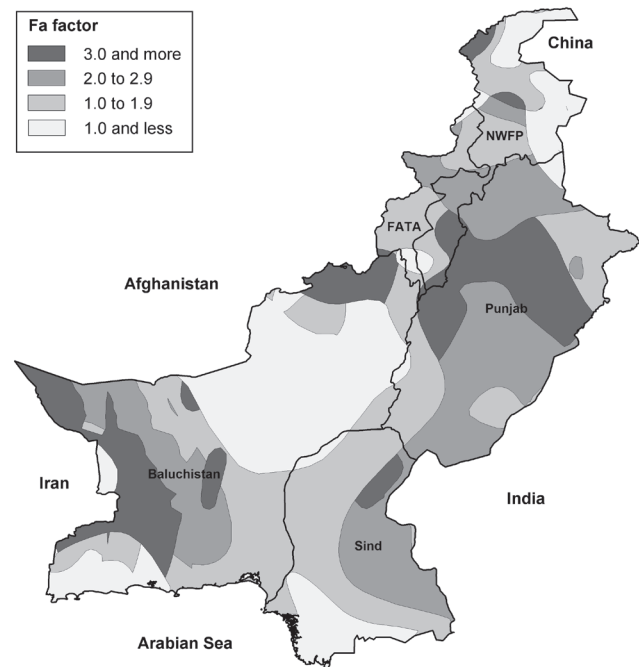
Figure 5 presents a comparison of the hazard assessed by the GSP and GSHAP in terms of peak ground acceleration (PGA). The hazard is assessed in terms of PGA (m/sec^2) with 10% probability of exceedance in 50 years. In PGA comparisons, an “ F_a factor” is used to identify the areas where the difference is more acute. For intensity comparison, the PGA values can be converted into intensity by several correlations, *e.g.*, Murphy and O’Brien (1977), Wald *et. al.* (1999), and, recently, Atkinson and Kaka (2007). The above-mentioned relations are used to prepare intensity maps, but no identical solution is found in the case of GSP, which has identical maps in terms of

▲ **Figure 5.** Comparison of GSP (A and B) and GSHAP hazard assessment (C and D). The F_a factor defines the level of difference between the two hazard assessments. The hazard assessed in the two maps is the same in the regions where the F_a factor is 1.0. The higher the F_a factor, the higher the difference between the GSHAP and GSP hazard assessment. That means that the GSP has underestimated the hazard.

In the first step, for the assessment of potential seismic losses, work with deterministic event scenarios coupling the seismic hazard with the vulnerability of the built environment and the exposed values could be done. Improvement in the assessment of the seismic hazard in Pakistan is being carried out, but needs further revision, as observed in figure 5 in the F_a factor.

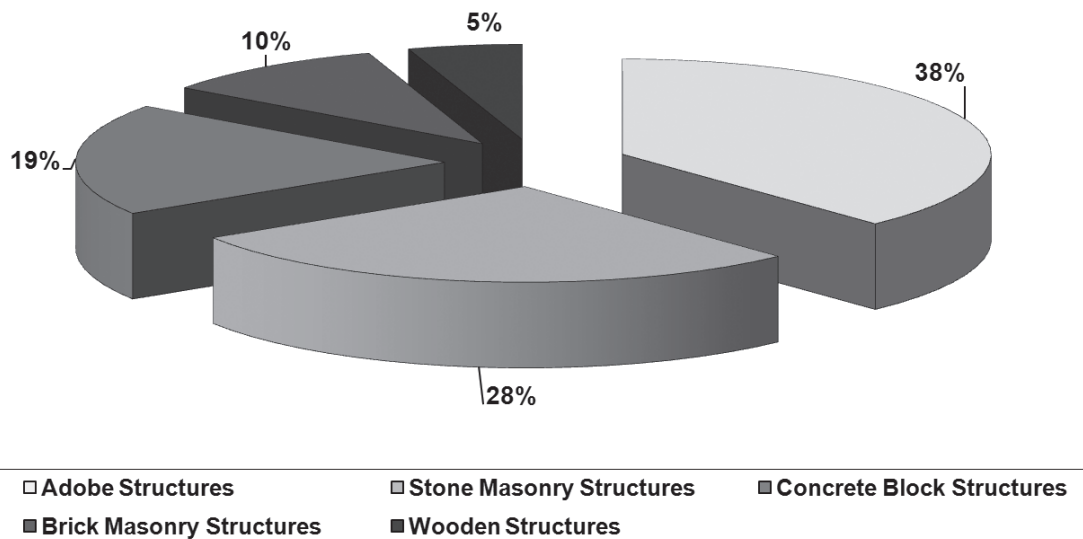
The majority of the building stock consists of non-engineered structures. The building stock in the region can be classified into five categories depending upon the material used in walls and roofs. The distribution of the various building types in the affected areas is shown in figure 6.

▲ **Figure 6.** Building type distribution in affected areas.

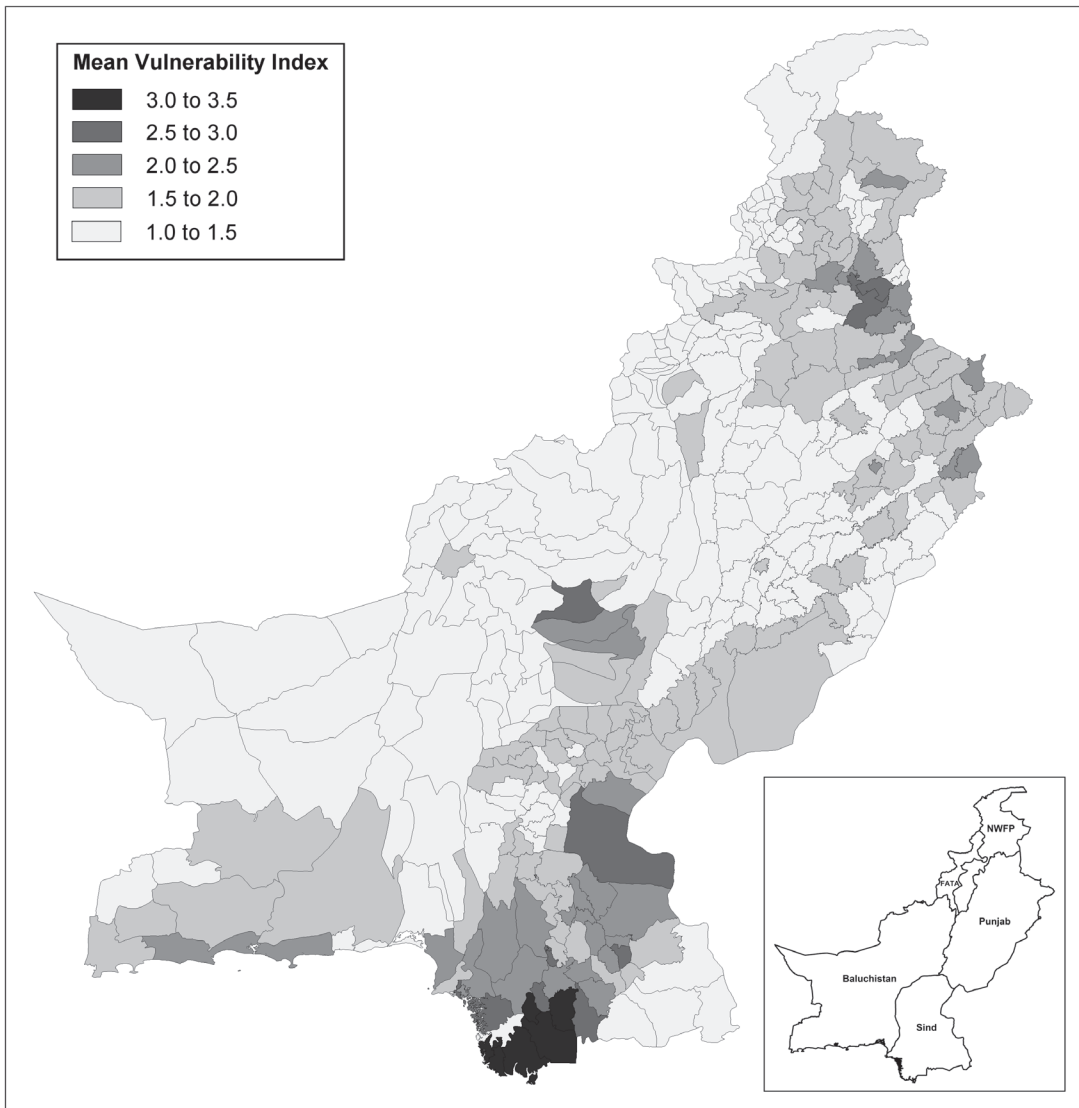
▲ **Figure 7.** Mean vulnerability index (MVI) of building stock in Pakistan.

Figure 7 presents the regionalization factor in terms of mean vulnerability index (MVI), which shows the mean vulnerability class of the building stock in an administrative unit according to EMS-98. For calculating the MVI, a number from 1 to 6 is assigned for each vulnerability class from A to F. Taking the mean over the different percentages of each vulnerability class leads to a prediction of the mean vulnerability index for a certain building stock.

The lower the MVI, the higher the vulnerability of buildings to damage. From figure 7, it is clear that buildings in Pakistan have low resistance for earthquake shaking and are vulnerable to damage during an earthquake.
