Landslides and Other Slope Failures

1.1 Introduction

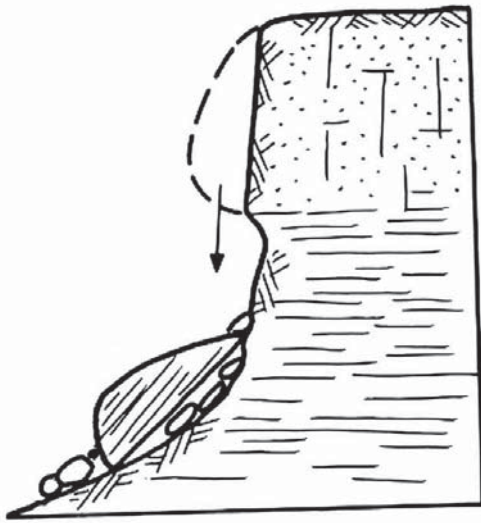
FIGURE 1.1

Forms of falls in rock masses: (a) free fall;
(b) toppling by overturning.

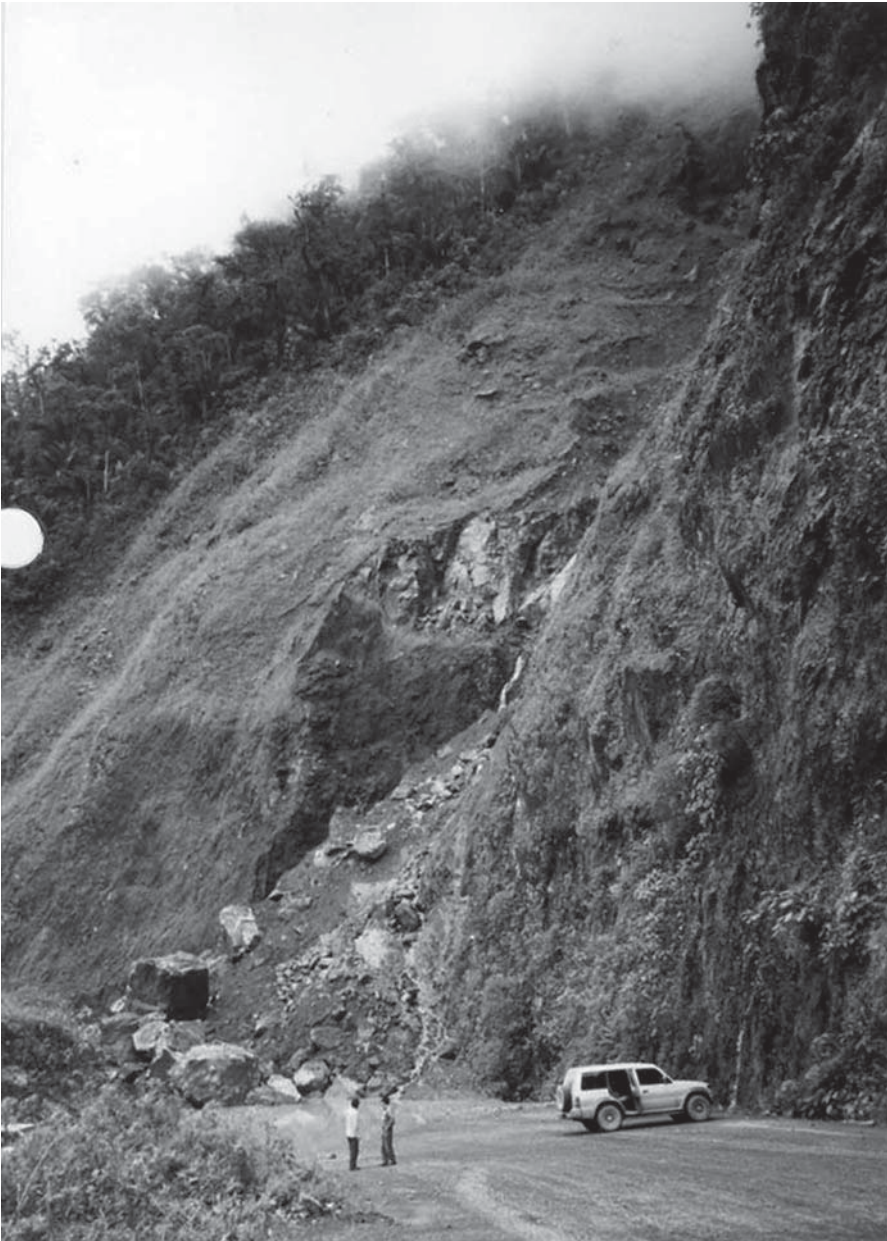
FIGURE 1.5

Debris avalanche closes a roadway in Ecuador for some days. A temporary bypass was constructed and used until the debris was removed.

Moderate risk: A more severe inconvenience, corrected with some effort, but not usually directly endangering lives or structures when it occurs, such as a debris slide entering one lane of a roadway and causing partial closure for a brief period until it is removed. Figure 1.5 illustrates a debris avalanche that closed a roadway for some days.

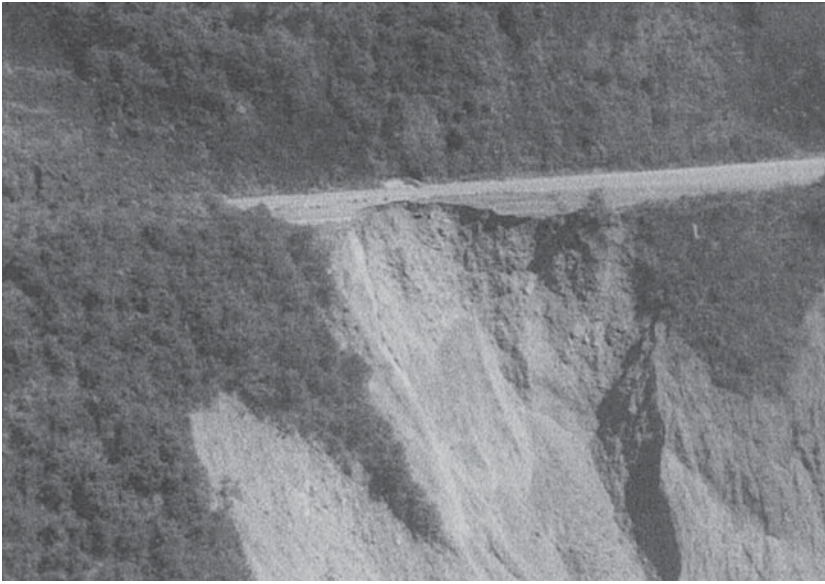
FIGURE 1.6

Partial loss of mountain roadway in Ecuador. Failure resulted from discharge from roadway drains causing downslope erosion. Additional failure will result in total loss of roadway and closure probably for months.

High risk: Complete or partial loss of a roadway or important structure, or complete closure of a roadway for some period of time, but lives are not necessarily endangered during the failure. Figure 1.6 illustrates a partial loss of a roadway. If failure continues it will result in total loss of the roadway and will become a *very high risk* for traffic.

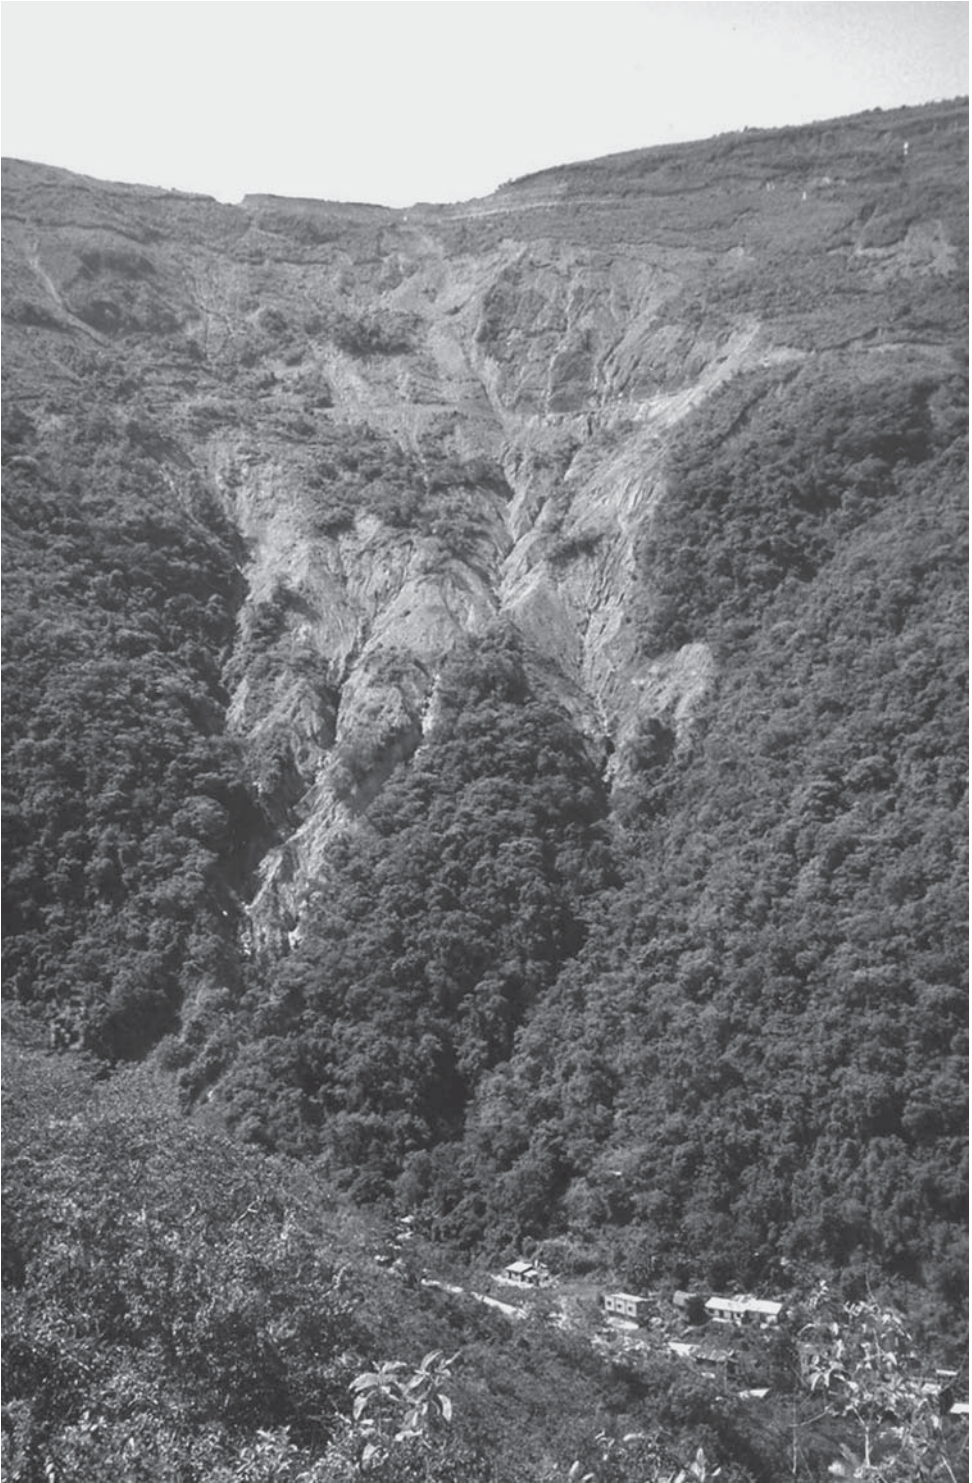
**FIGURE 1.7**

Debris avalanches resulted from roadway construction on a steep slope in the Bolivian Andes. The small town of Pacallo in the photo lower right is located adjacent to a fast-flowing mountain stream. The major concern was with future avalanches damming the stream with debris resulting in flooding of the town.

Very high risk: Lives are endangered at the time of failure by, for example, the destruction of inhabited structures or a railroad when there is no time for a warning. The scars on the steep slopes in Figure 1.7 are the result of debris slides and avalanches resulting from roadway cuts upslope. The town shown on the lower right of the photo is located on the banks of a river. Concerns were from debris avalanches (1) filling and damming the river resulting in flooding of the town, and (2) falling on the town. Studies showed that the width, depth, and flow velocity of the river would remove any foreseeable volume of debris, and damming would not be expected. As long as the vegetation upslope of the town remained, the slope would be stable. Treatments were recommended to stabilize the areas upslope where failures had occurred. Therefore, the possible very high risk was reduced to low.

Three-dimensional diagram of a new roadway in the Andes of Bolivia. Steep slopes and irregular landform results in numerous cuts. See Figure 1.7 for debris avalanches above town of Pacallo, and at km 36, Figure 1.52.

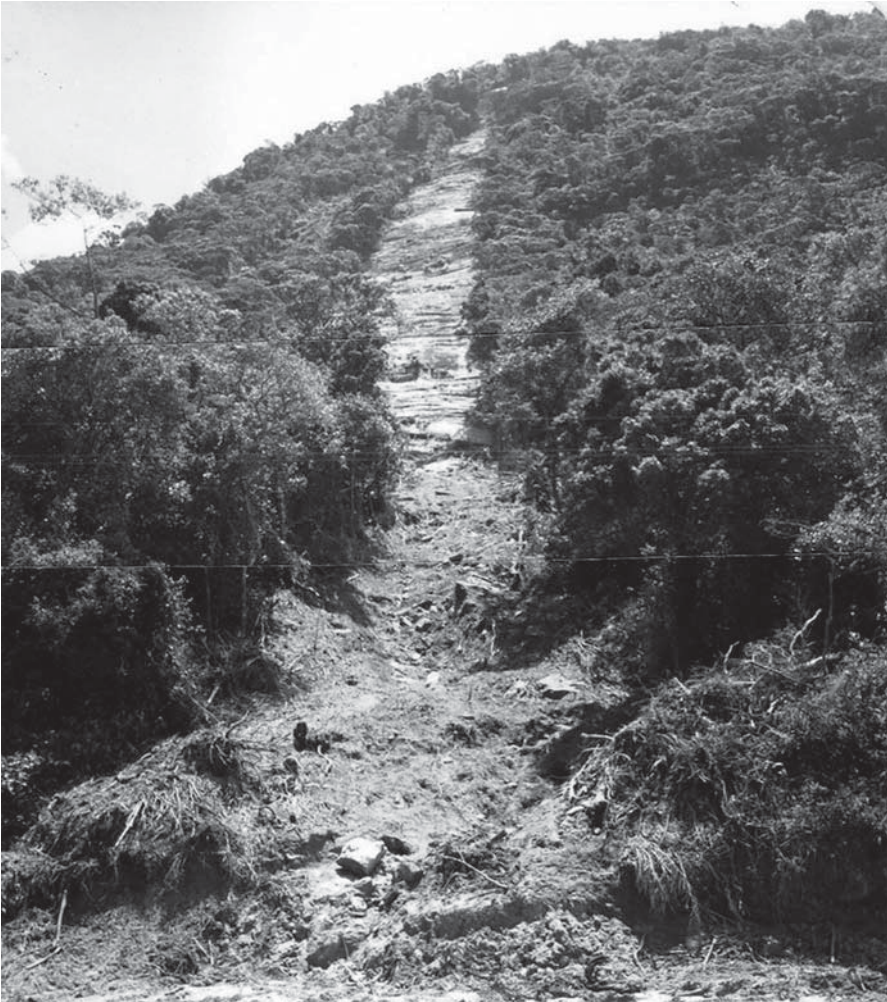
FIGURE 1.10

Exposed rock surface remaining after runoff from torrential rains removed all vegetation, soil, and loose rock, depositing the debris mass at the toe of the slope (BR 116, km 56, Teresopolis, R. J., Brazil).

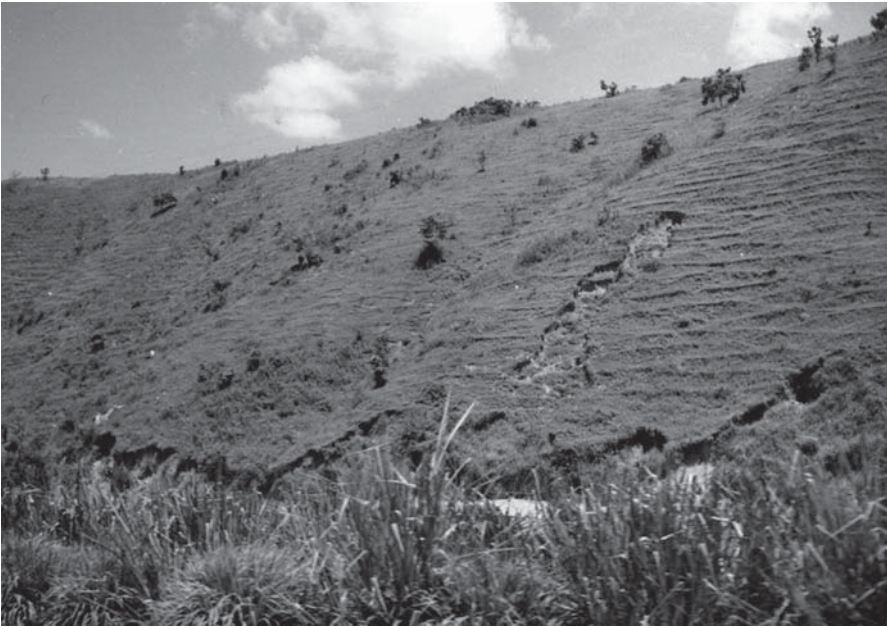
FIGURE 1.11

Creep ridges and erosion in residual soils after removal of vegetation (state of Rio de Janeiro, Brazil).

as illustrated in Figure 1.11, and tilted fence posts, poles, and tree trunks. Straight tilted tree trunks indicate recent movement (Figure 1.12), whereas bent tree trunks indicate old continuing movement (Figure 1.13) (see Section 1.5.2, Dating Relict Slide Movements).

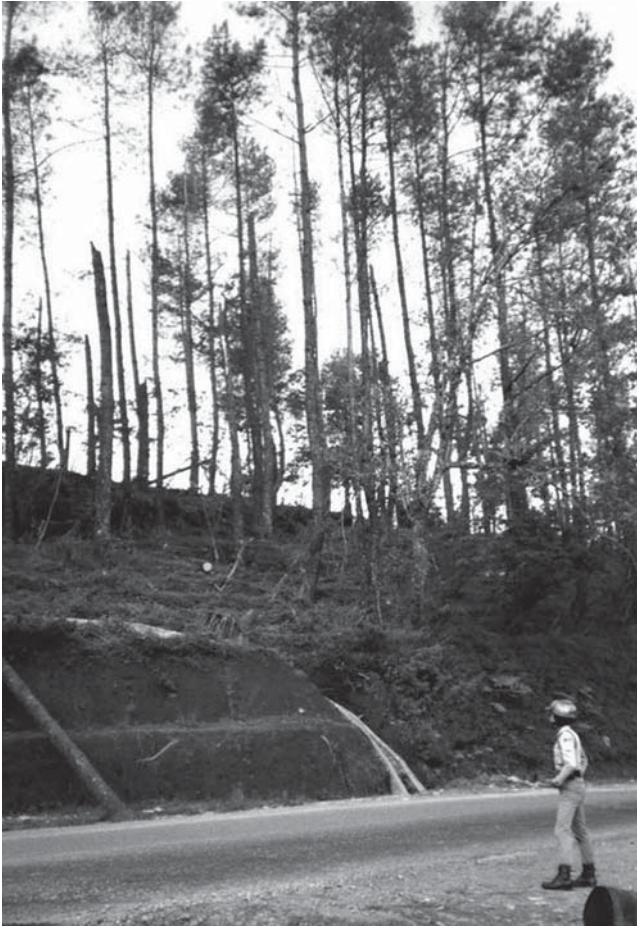
FIGURE 1.12

Trees bent in the lower portions and then growing straight up indicate long-term slope movements. The scarp in the photo is the head of a progressive failure in marine shales extending downslope for over a kilometer near Bandung, Java.

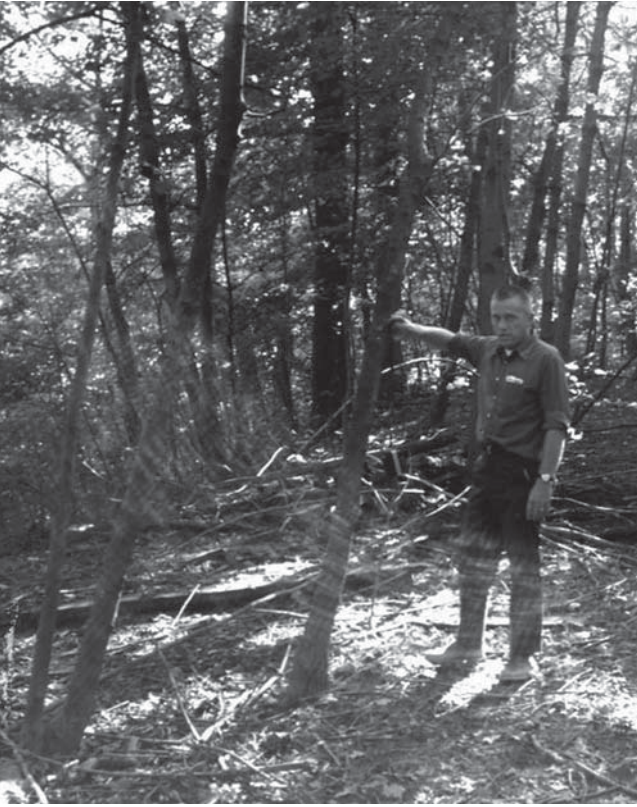
FIGURE 1.13

Tilting tree trunks on a creeping hillside of varved clays indicate relatively recent movement (Tompkins Cove, New York).

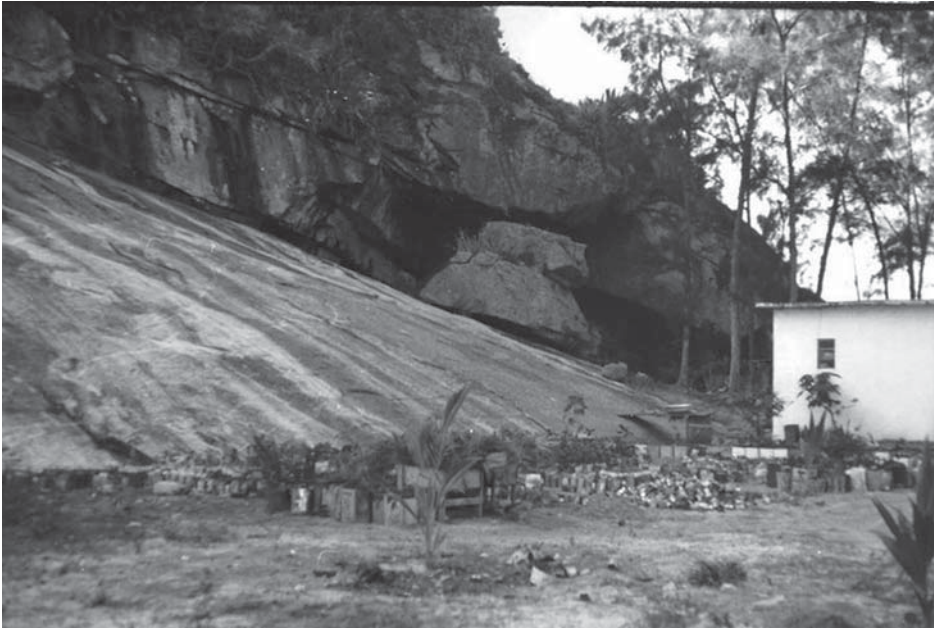
FIGURE 1.15
Small granite block glide (Rio de Janeiro, Brazil).

- Block glide involving a single unit of relatively small size (photo, Figure 1.15).
- Slab glide involving a single unit of relatively small to large size (photo, Figure 1.16).
- Wedge failures along intersecting planes involving single to multiple units, small to very large in size (Figure 1.2d). A small wedge failure is illustrated in Figure 1.81.
- Translational slide: Sliding as a unit, or multiple units, downslope along one or more planar surfaces (Figure 1.2b). Failure often is progressive (Section 1.2.6).
- Massive rock slide involving multiple units, small to very large in size, often with very high velocities (Figure 1.17).

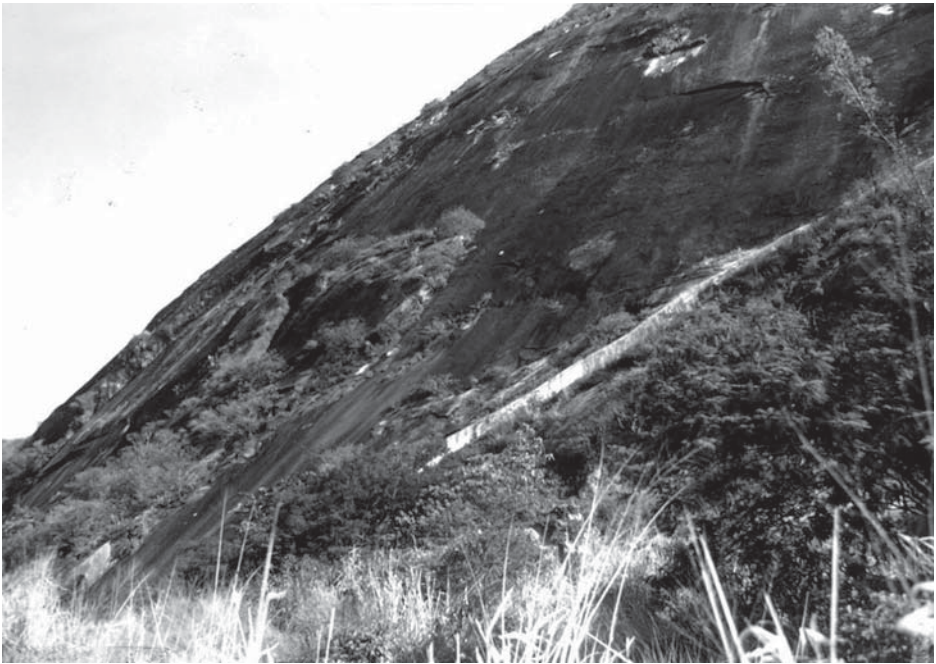
FIGURE 1.16
Exfoliation loosening granite slabs. Impact wall on right was constructed to deflect falling and sliding blocks from buildings on lower slopes. Damage from falls and slab slides is a serious problem in Rio de Janeiro.

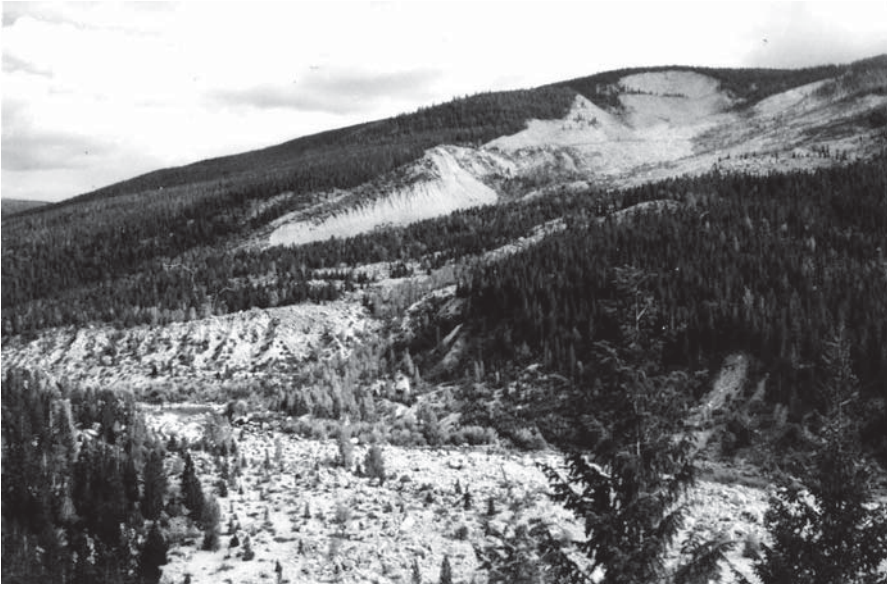
FIGURE 1.17

The scar of the Gros Ventre slide as seen from the Gros Ventre River, Wyoming, in August 1977.

The slide scar which is still evident in 1977, 52 years later, is illustrated in Figure 1.17. A geologic section is given in Figure 1.18. Failure occurred along clay layers in the carbonaceous Amsden formation, dipping downslope. It appears that water entered the joints and pores of the Tensleep sandstone saturated the clay seams, and reduced or eliminated the normal stresses.

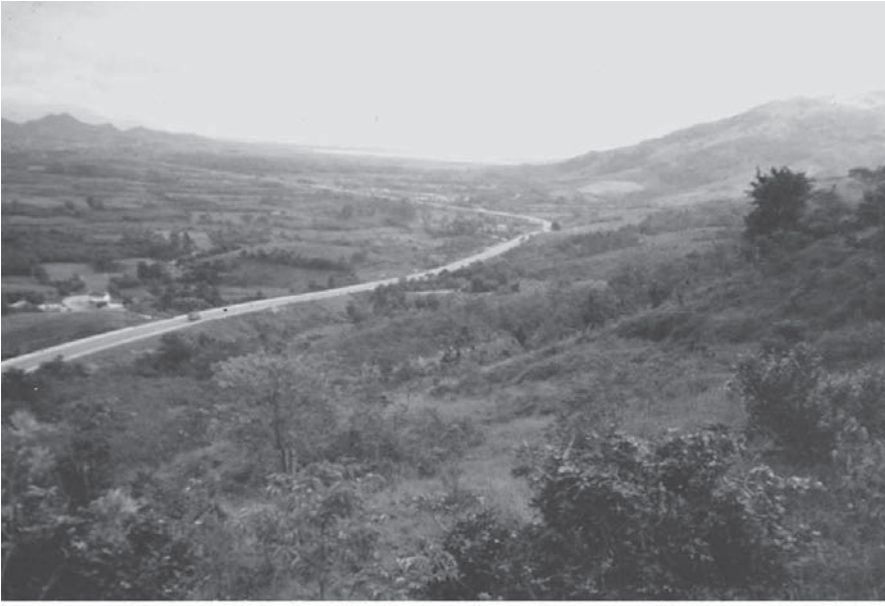
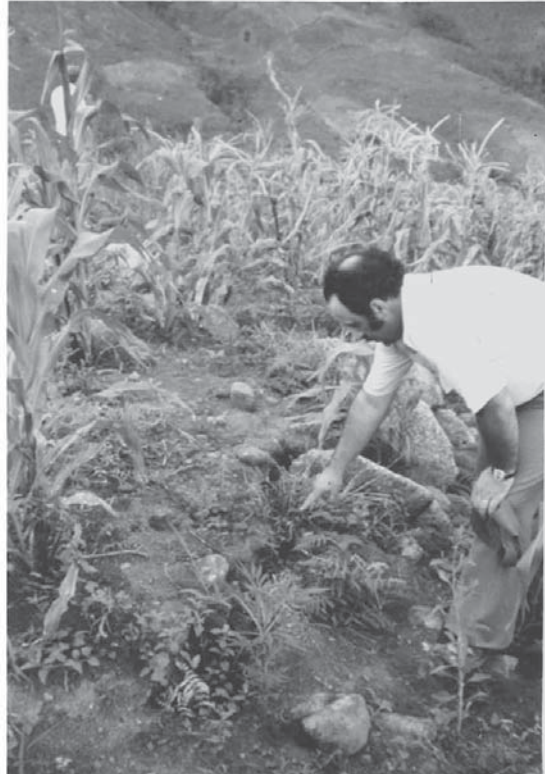
**FIGURE 1.22**

(a) Small scarp along tension crack appears in photo (middle right). Small highway cut is far below to the left. Scarp appeared after soil was removed from small slump failure at the toe (BR 101, Santa Catarina, Brazil). Movement is in residual soil. If uncorrected, a very large failure will develop. (b) Tension crack in the same slope found in another location.

During *early failure stages* tension cracks begin to form as shown in Figure 1.22 and Figure 1.23. After *partial failure*, in a progressive mode, the slope exists as a series of small slumps and scarps with a toe bulge as shown in Figure 1.24, or it may rest with a single large scarp and a toe bulge as illustrated in Figure 1.25(a). After *total failure*, surface features include a large head scarp and a mass of incoherent material at the toe as shown in Figure 1.25(b) and Figure 1.93.

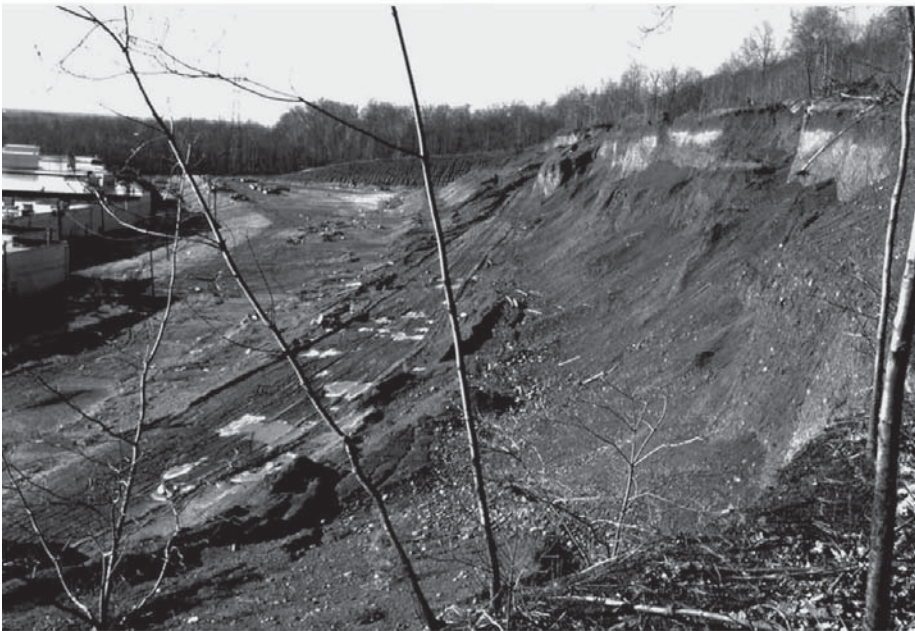
FIGURE 1.25

Slump failure occurred after cutting in fine-grained glacial till (Mountainside, New Jersey). (a) Head scarp, toe bulge, and seepage at the toe. (b) Total failure some weeks later. Slope stabilized by benching, installation of trench drain, and counterberm along the toe.

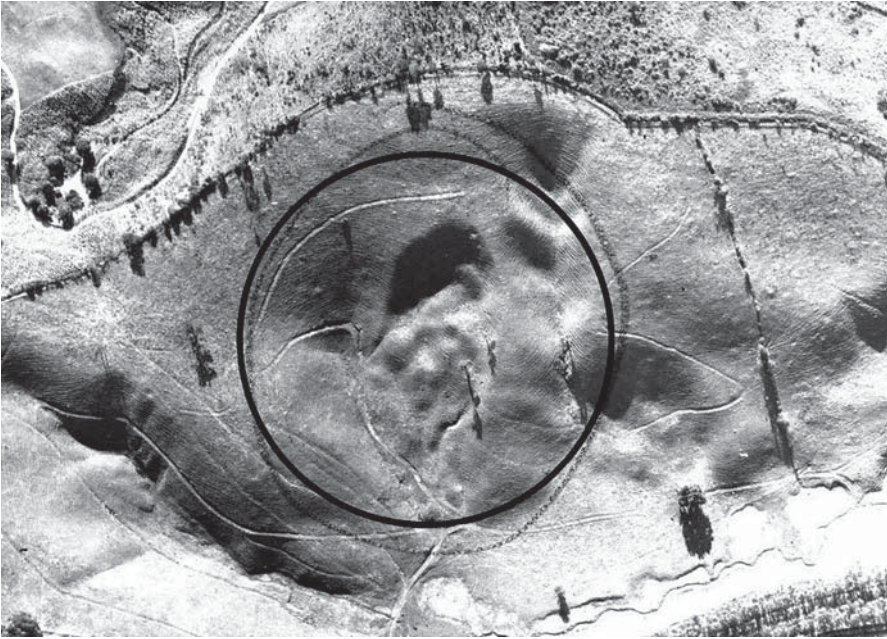
FIGURE 1.27
Old slump slide in residual soils located near slide in Figure 1.26.

Slump landforms remaining after total failures provide forewarning of generally unstable slope conditions. They include spoon-shaped irregular landforms, as seen from the air (Figure 1.26 and Figure 1.27), cylindrical scarps along terraces and water courses, and hummocky and irregular surfaces, as seen from the ground (Figure 1.28 and Figure 1.29). In the stereo-pair of aerial photos shown in Figure 1.26, the slump failure mass has stabilized temporarily but probably will reactivate when higher than normal seasonal rainfall arrives. A small recent failure scar exists along the road in the center of the slide mass. The rounded features of the mass, resulting from weathering, and vegetation growth indicate that the slide is probably 10 to 15 years old, or more. In the photo, it can be seen that the steep highway cut on the opposite side of the valley appears stable, indicative of different geologic conditions. In general, the geology consists of residual soils derived from metamorphic rocks in a subtropical climate. In Figure 1.27, an old slump scar in residual soils, weathering has strongly modified the features. In the photo, the tongue lobe at the intersection of the trails and the creep ridges are to be noted. The location is near the slide of Figure 1.26.

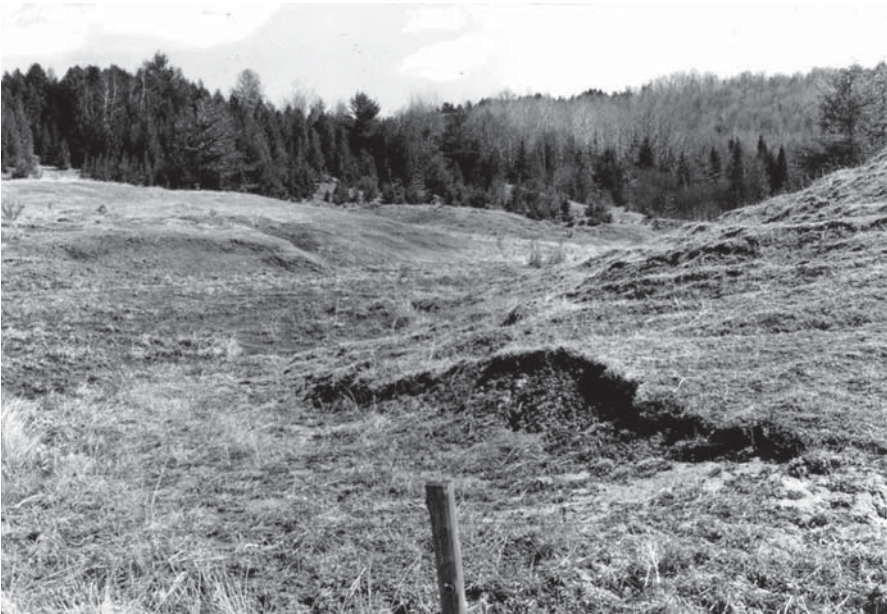
FIGURE 1.28
Slump landform in glaciolacustrine soils showing shallow slopes, creep ridges, and seepage (Barton River, Vermont). Trees in upper left are growing on slide area. Slope failures are common in this region in the spring when the ground thaws and rains arrive.

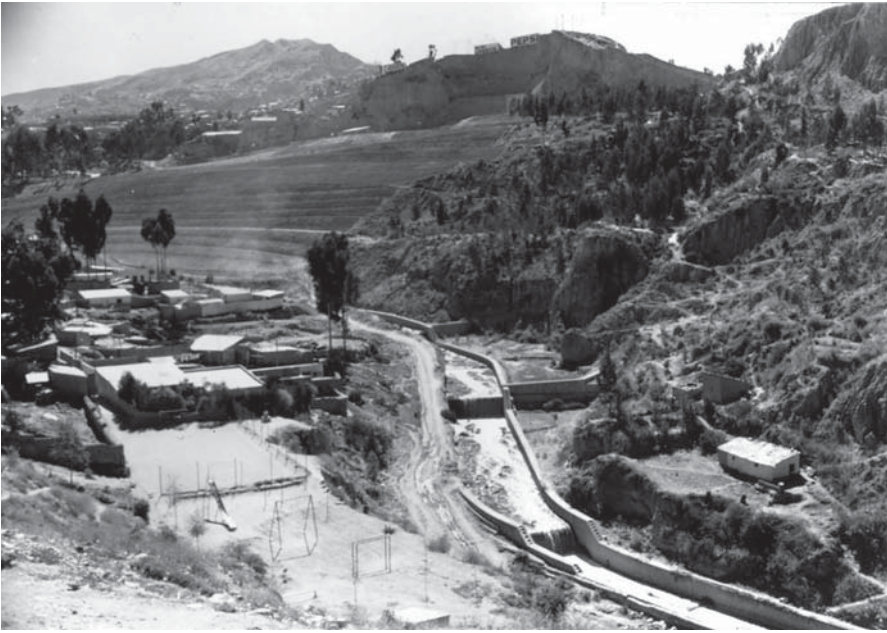
FIGURE 1.29

Slump-slide landform (valley of the Rio Choqueyapa, La Paz, Bolivia). High center scarp in strong sands and gravels remains after failure of underlying lacustrine soils. Slopes were extremely unstable prior to channelization of the river, because of river erosion and flood stages. Grading of old slide in upper left is not arresting slope movements as evidenced by cracks in new highway retaining wall (not apparent in photo). Slope failures continue to occur from time to time throughout the valley (photo taken in 1973).

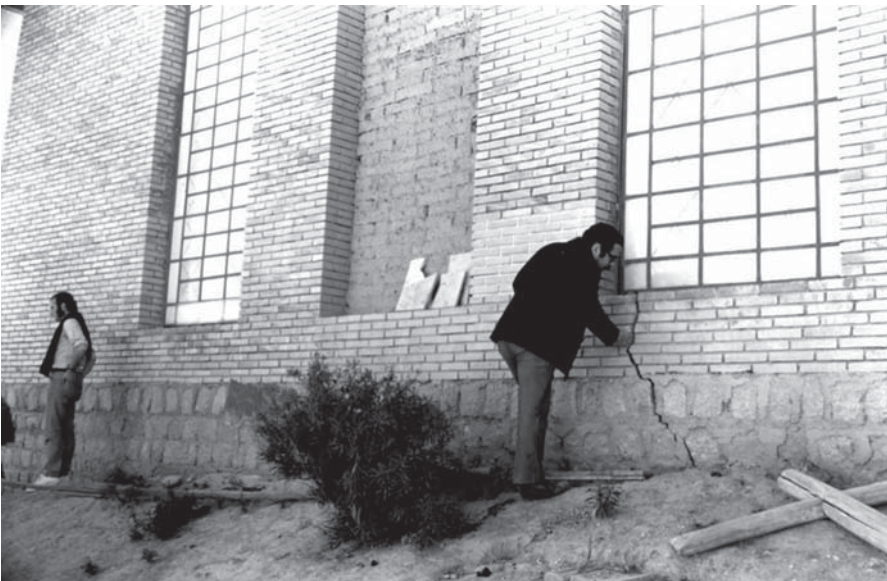
FIGURE 1.30

One-year-old church being split into half from slope movements although located over 1 km from the slope shown in Figure 1.29 (La Paz, Bolivia, 1972).

progressive failure tension cracks open and scarps form, separating large blocks. The cracks can extend far beyond the slope face when a large mass goes into tension, even affecting surface structures as shown in Figure 1.30. Final failure may not develop for many years, and when it occurs it may be in a form resembling a large slump slide, or it may develop into a flow with individual blocks floating in a highly disturbed mass, depending upon natural conditions as described in the examples below.

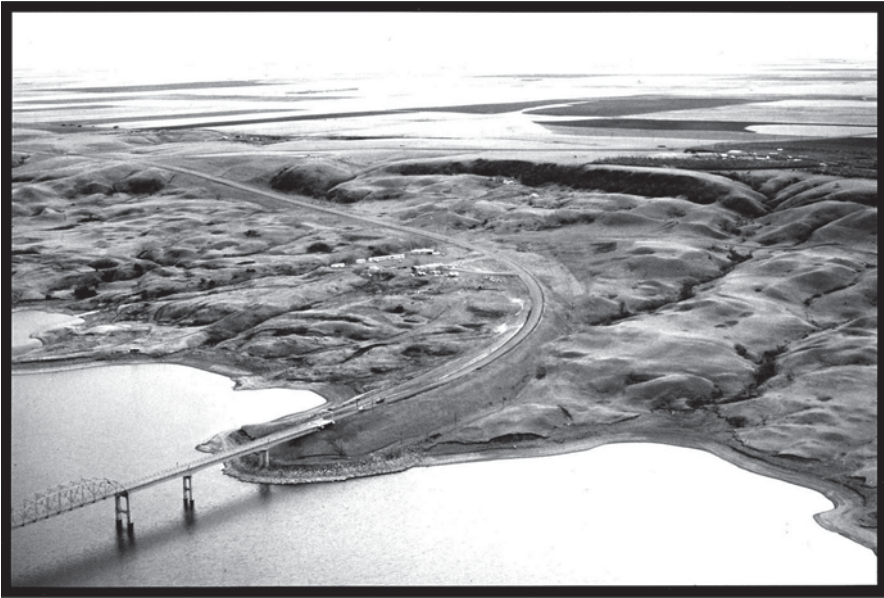
FIGURE 1.32

Aerial oblique, Forest City Landslide, South Dakota. Note the head scarp and hummocky landform. (Photo by Vernon Bump, SDDOT.)

The Forest City Landslide, located on the banks of the Oahe Reservoir in South Dakota, includes an area of about 700 acres (Hunt et al., 1993). The hummocky landform, typical of marine shales and a large head scarp, is shown in the aerial oblique of Figure 1.32. Movements toward the reservoir, of the order of several inches or more per year, were causing distress in a large bridge structure. Investigations, including test borings and inclinometer data, identified the main failure surface at depths of the order of 100 ft, extending upslope to the head scarp, a distance of 2200 ft. The approach roadway embankment was moving laterally on shallower failure surfaces. A geologic section is given in Figure 1.33.

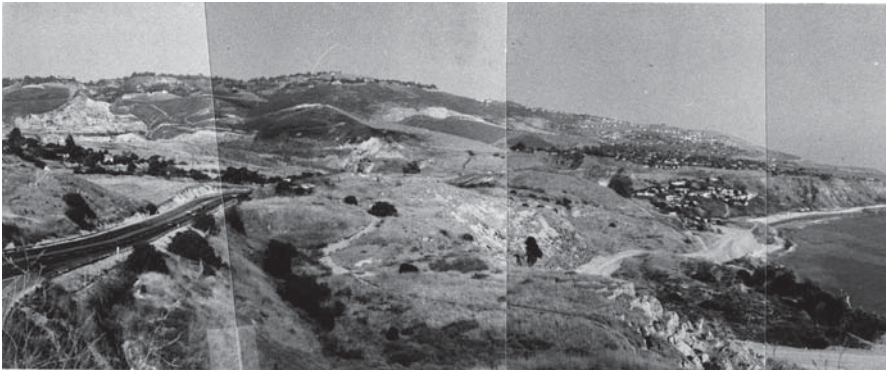
FIGURE 1.38
 Panorama of the Portuguese Bend landslide looking south. The highway on the left is continually moving, and the old abandoned road appears in the photo center. The broken ground on the right is the head scarp of rotational slides in the frontal lobe of the unstable mass (photo taken in 1973).

area, the land rises from the sea in a series of gently rolling hills and terraces to more than 600 ft above sea level. The hills beyond the slide area rise to elevations above 1200 ft and the cliffs along the oceanfront are roughly 150 ft above the sea. A panoramic view of the slide is given in Figure 1.38.

Stabilization: Because of the large area involved and the geologic and other natural conditions, there appears to be no practical method of arresting slide movements. The cracks on the surface are too extensive to consider sealing to prevent rainwater infiltration, and the strength of the tuff layer is now inadequate to restrain gravity movement even during the dry season. A possible solution to provide stability might be to increase the shearing resistance of the tuff by chemical injection. Since this would be extremely costly, it appears prudent to leave the unstable area as open space although continuous maintenance of the roadway in Figure 1.38 has been necessary.

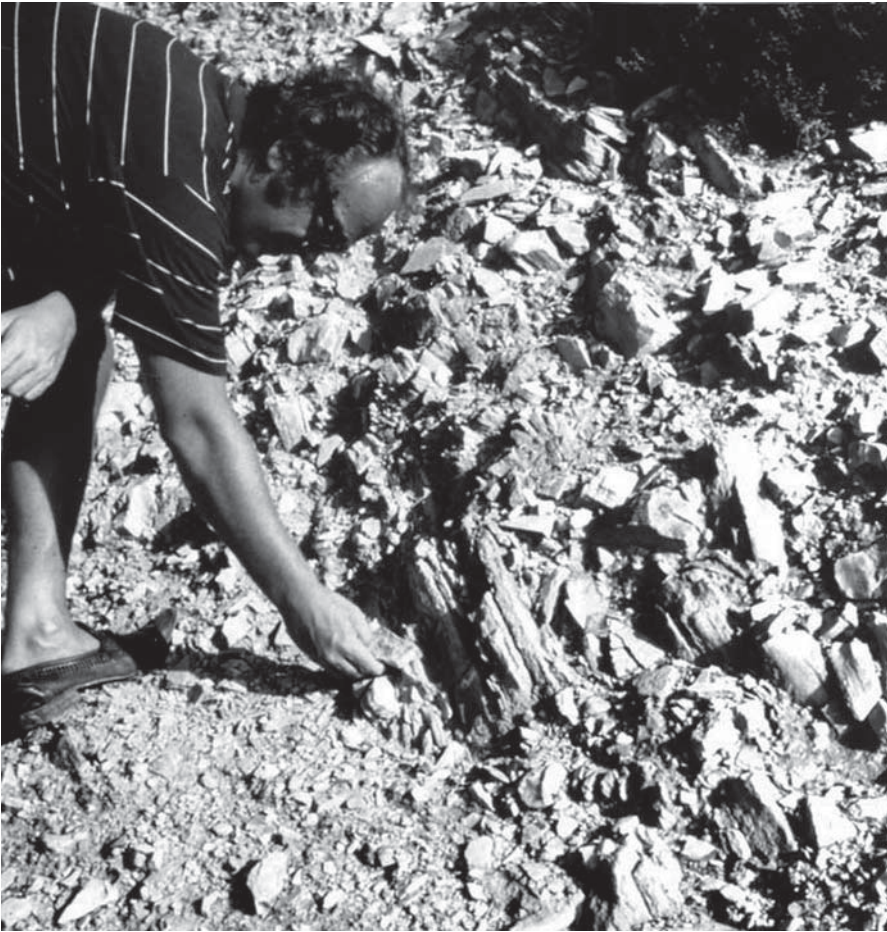
FIGURE 1.40

Soil “breccia” of fragments of indurated clayey silt in a crushed uplifted zone at Portuguese Bend.

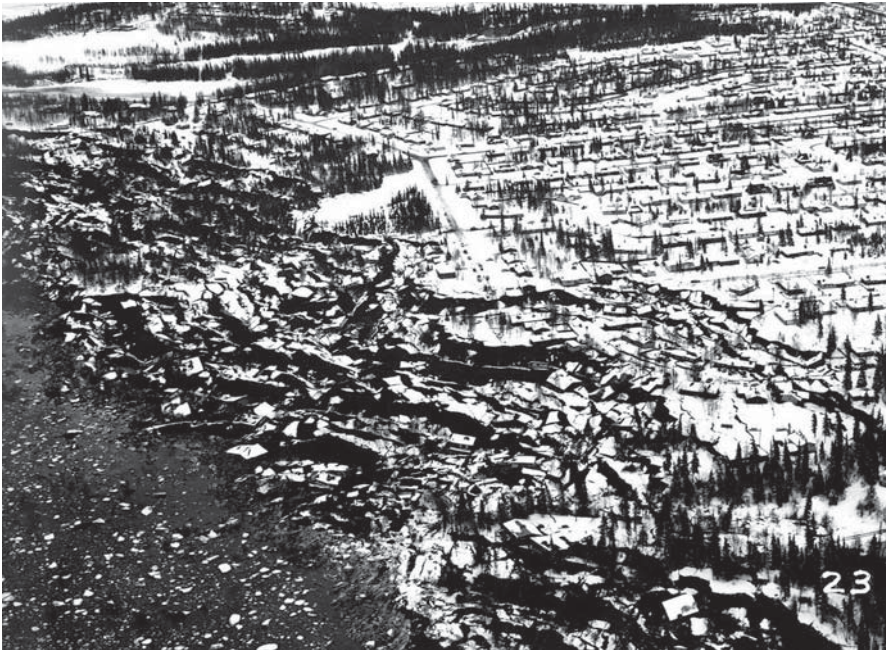
FIGURE 1.44

Failure by block gliding and lateral spreading resulting from the 1964 earthquake, Turnagain Heights, Anchorage, Alaska. (Photo courtesy of U.S. Geological Survey, Anchorage.)

Event: Much of the damage to the Anchorage, Alaska, area from the March 1964 earthquake was caused by landslides induced by seismic forces. The slides occurred in the city in the Ship Creek area and along the waterfront formed by the Knik Arm of Cook Inlet. The largest slide occurred at Turnagain Heights, a bluff some 60 ft high overlooking Knik Arm. Many homes were destroyed in the slide area of 125 acres as illustrated in Figure 1.44. The slide at Turnagain Heights is an example of sliding along horizontal strata. It was planar and

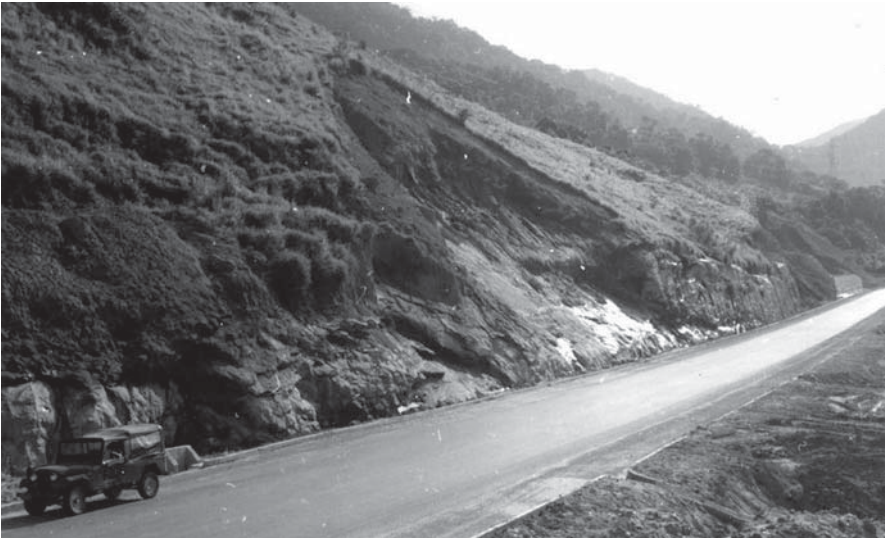
FIGURE 1.46

Small debris-slide scar along the Rio Santos Highway, Brazil. Note seepage along the rock surface, the sliding plane. Failure involved colluvium and the part of the underlying rock. The area subsequently was stabilized by a concrete wall.

Occurrence is common in colluvial or residual soils overlying a relatively shallow, dipping rock surface. During the initial stages of development, tension cracks are commonly formed. After partial failure, the tension cracks widen and the complete dislodgment of one or more blocks may occur, often leaving a clean rock surface and an elliptical failure scar as shown in Figure 1.46. Total failure can be said to have occurred when the failure

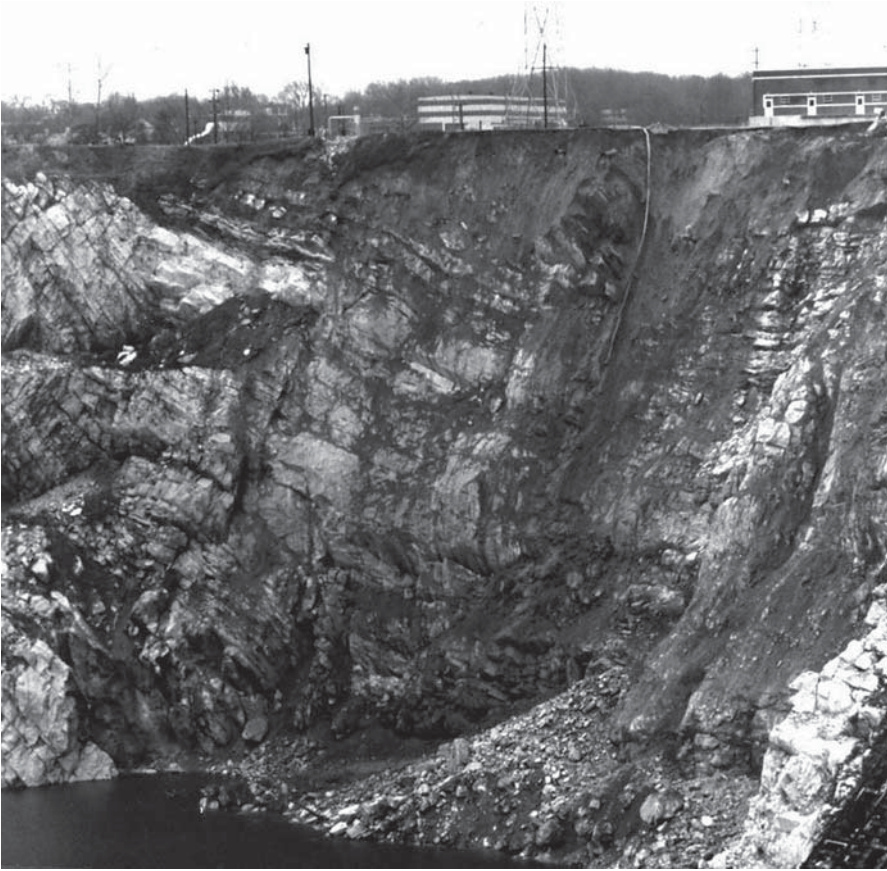
FIGURE 1.47

Scarred surface remaining after a rock and debris avalanche in a limestone quarry. The rock is heavily jointed with sets oriented more or less parallel to the slope and across the bedding plane. Failure was induced by wedging from water and ice pressures, and occurred in the early spring.

Debris avalanches are characteristic of mountainous terrain with steep slopes of residual soils where topography causes runoff concentration (see Figure 1.86), or badly fractured rock such as illustrated in Figure 1.47.

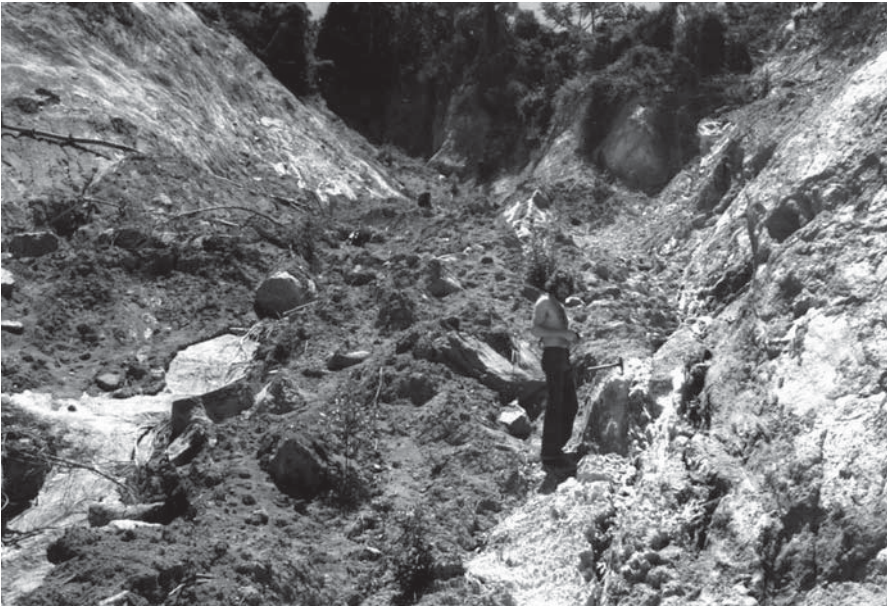
FIGURE 1.48

The force of hydraulic excavation is evident in this photo taken in a typical V-shaped scarred zone of a debris avalanche. Location is near the crest of the hill in Figure 1.49. The bedrock surface is exposed.

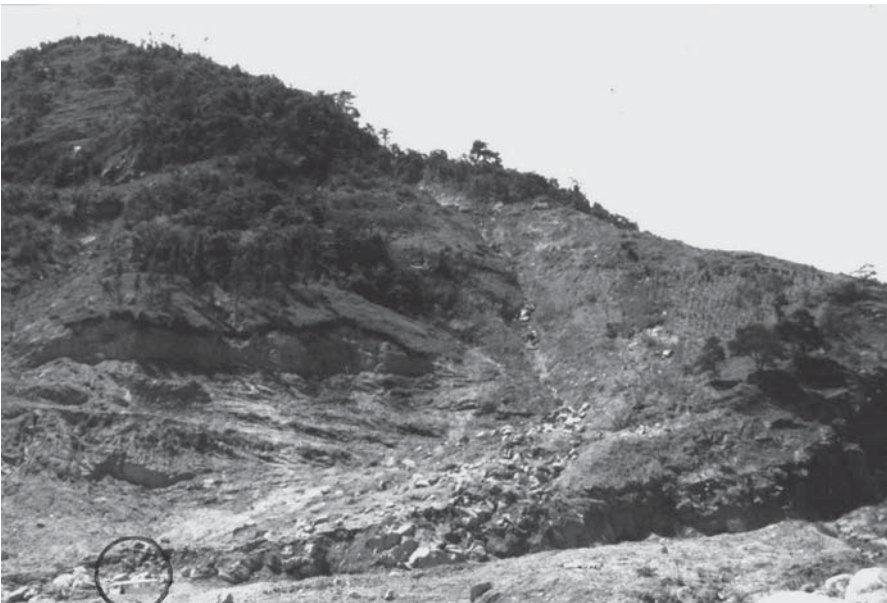
FIGURE 1.49

Debris avalanche that covered BR 101 near Tubarao, Santa Catalina, Brazil during torrential rains in 1974. Note the minibus for scale. The debris lobe crossed the highway and continued for a distance of about 200 m and carried boulders several meters in diameter. Debris has been removed from the roadway. It is unlikely that a failure of such a magnitude could have been foreseen for this particular location.

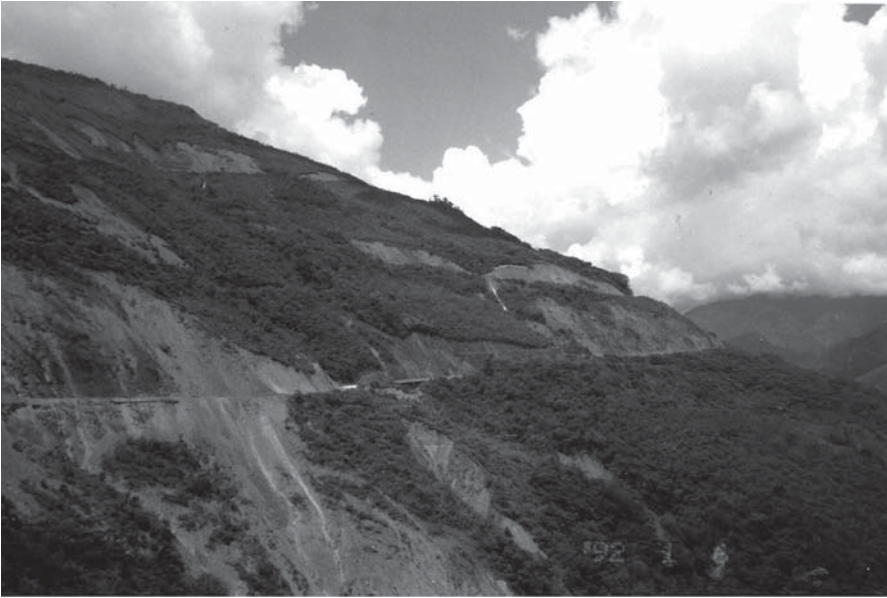
FIGURE 1.52

Debris avalanches at km 36 along the roadway shown in Figure 1.51. There were no slope failures at the beginning of construction in 1995. The photo, taken by the author, shows conditions during 2002, after several years of El Niño. At this time construction was not complete.

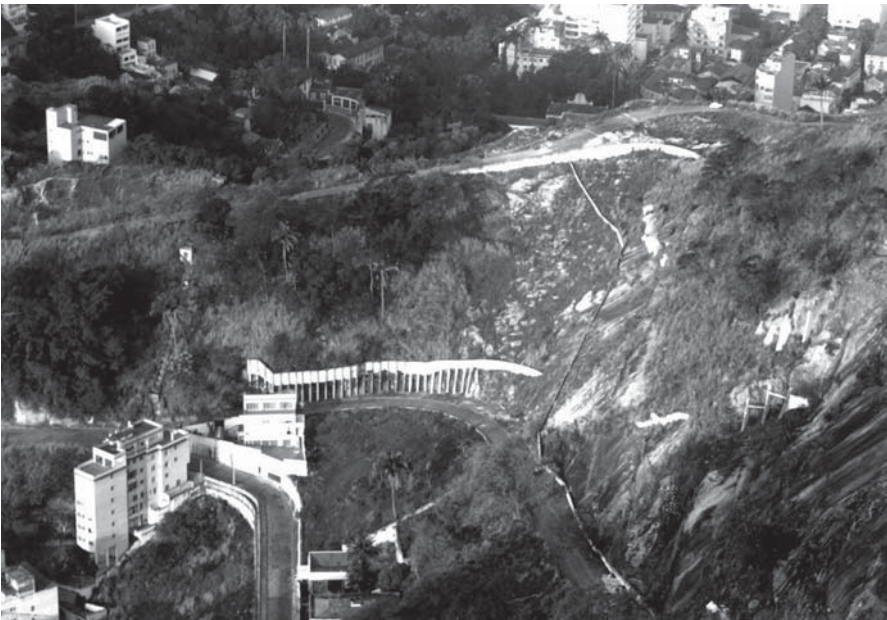
FIGURE 1.53

Scar of debris avalanche of February 18, 1967, which destroyed two apartment buildings and took 132 lives in the Larenjeiras section of Rio de Janeiro. The buttressed wall was constructed afterward. Debris avalanches need not be large to be destructive.

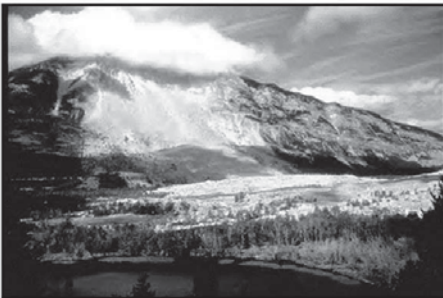
FIGURE 1.54

Turtle Mountain rock slide, Frank, Alberta in 1903. (a) Geologic section (From Krahn, J. and Morgenstern, N. R., *Proceedings of ASCE, Rock Engineering for Foundations and Slopes*, Vol. 1, 1976, pp. 309–332. With permission.) (b) Photo of scar (source unknown).

The mountain is the limb of an anticline composed of limestone and shales as shown in the section in Figure 1.54a. Failure was sudden, apparently beginning in bedding planes in the lower shales (Krahn and Morgenstern, 1976) which are steeply inclined. The slide scar is shown in Figure 1.54b.

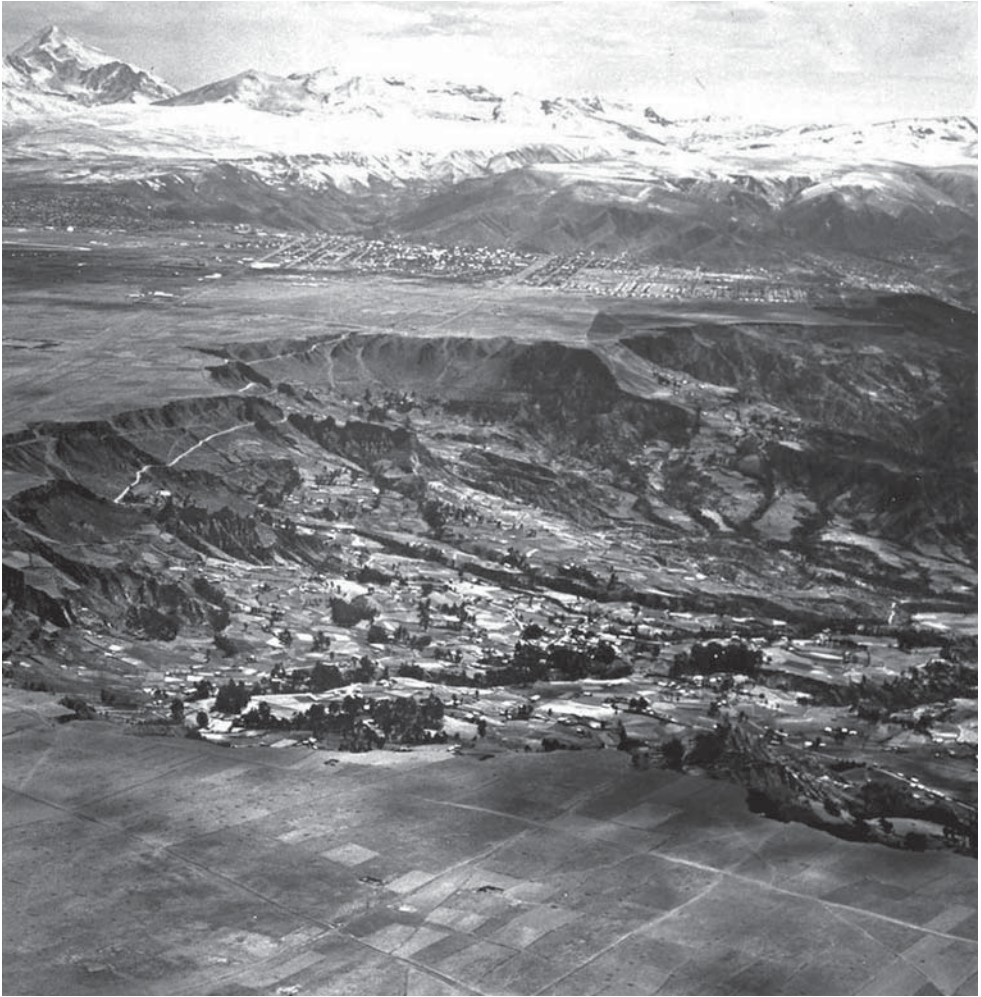
FIGURE 1.56

The head scarp of the Achocallo mud flow, near La Paz, Bolivia (see Figure 1.55).

Believed triggered by an earthquake some thousands of years ago, an enormous portion of the rim of the Bolivian altiplano (elevation 4000 m), roughly 9 km across, slipped loose and flowed down the valley of the Rio Achocallo into the Rio La Paz at an elevation approximately 1500 m lower. The flow remnants extend downstream today for a distance of about 25 km, part of which are shown on the aerial oblique panorama given in Figure 1.55. The head scarp is shown on the photo (Figure 1.56).
