Landslides and Other Slope Failures

1.1 Introduction

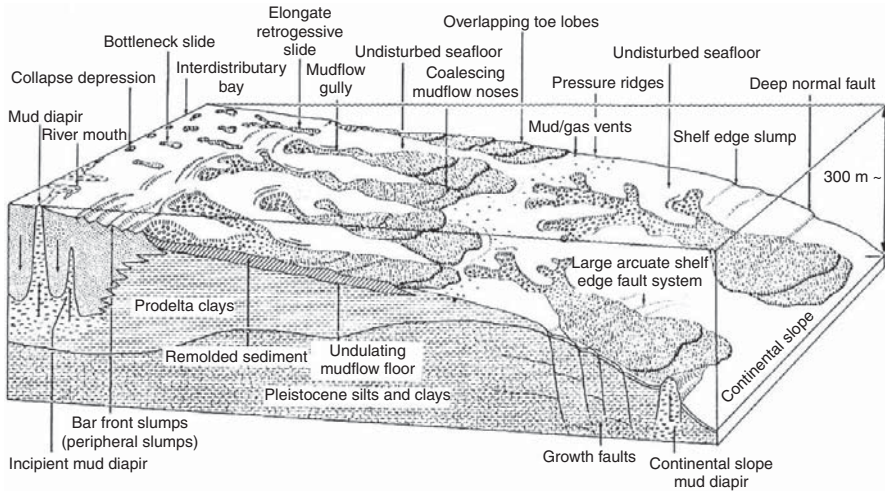
FIGURE 1.58

Schematic block diagram illustrating the various forms of slope failure in the offshore Mississippi River Delta. (From Coleman, J. M. et al., *Open File Report No. 80.01*, Bureau of Land Management, U.S. Department of Interior, 1980. With permission.)

Various forms of slope failures have been recognized offshore, including deep rotational slides (Figure 1.57) and shallow slumps, flows, and collapsed depressions (Figure 1.58). Major causes are earthquakes, storm waves inducing bottom pressures, depositional loads accumulating rapidly and differentially over weak sediments, and biochemical degradation of organic materials forming large quantities of gases *in situ* which weaken the seafloor soils.

After failure the seafloor is distorted and scarred with cracks, scarps, and flow lobes similar to those features which appear on land as illustrated in Figure 1.58. Active areas are explored with side-scan sonar (Figure 1.59) and high-resolution geophysical surveys (see Figure 1.57).

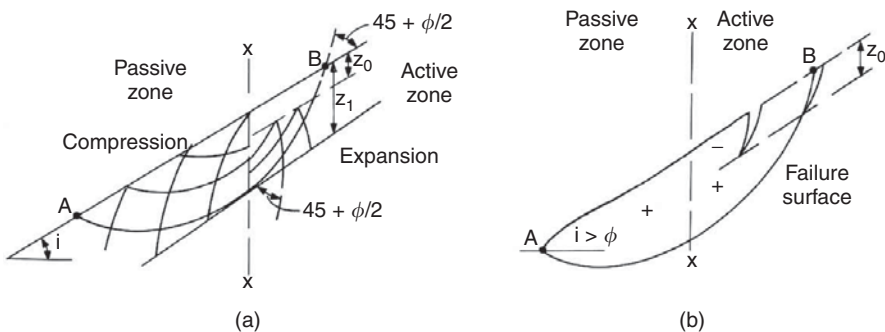
FIGURE 1.60

Active and passive stresses acting on a slope. The passive resistance at the lower portions is most significant. (a) Distribution of stresses on slope with $i > \phi$ (failure beginning). (b) A case of rupture where + indicates zones of passive stress and (-) indicates zones of active stress, subjected to tension cracks.

Failure origin: As stresses are usually highest at the toe of the slope, failure often begins there and progresses upslope, as illustrated in Figure 1.60, which shows the distribution of active and passive stresses in a slope where failure is just beginning. Failures can begin at any point along a failure surface, however, where the stresses exceed the peak strength. Because failure often is progressive, it usually occurs at some average shear strength that can be considerably less than the peak strength measured by testing techniques.

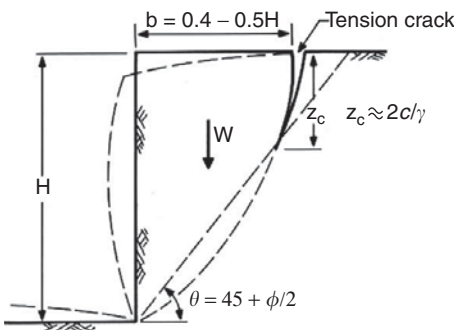
FIGURE 1.71
Critical height of a vertical slope in clay and the tension crack.

Case 6: Critical height and tension crack in clay (Figure 1.71). The critical height H_{cr} is defined as the maximum height at which a slope can stand before the state of tension, which develops as the slope yields, is relieved by tension cracks. Terzaghi (1943) gave the critical height in terms of total soil weight, having concluded that the tension crack would reach to one half the critical height, as

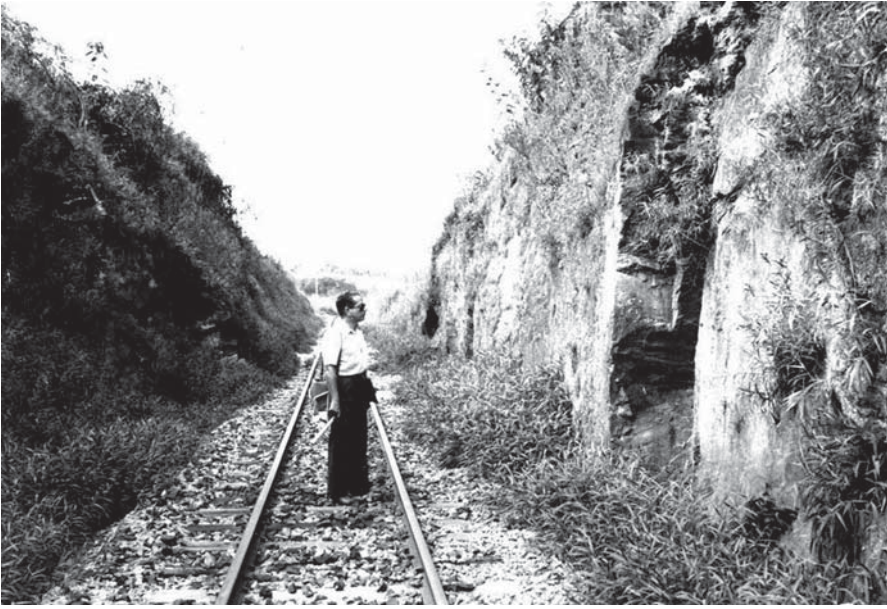
FIGURE 1.80

Near-vertical slope in 40-year-old railroad cut standing stable in amphibolite gneiss because of vertical jointing. (Tres Ranchos, Goias, Brazil). Compare with Figure 1.81.

Orientation of joints with respect to the rock slope face controls stability and the form of failure. The near-vertical slope in the 40-year-old railroad cut illustrated in Figure 1.80 is stable in decomposed amphibolite gneiss because of the vertical jointing. The cut shown in Figure 1.81 is near that of Figure 1.80 but at a different station and on the opposite side of the tracks. Here, the slope is much flatter, approximately 1:1, but after 40 years is still experiencing failures such as that of the wedge shown in the photo that broke loose along the upper joints and slid along a slickensided surface. These examples illustrate how joint orientation controls slope stability, even in "soft" rock. The cuts were examined as part of a geologic study for 30 km of new railroad to be constructed in the same formation but some distance away.

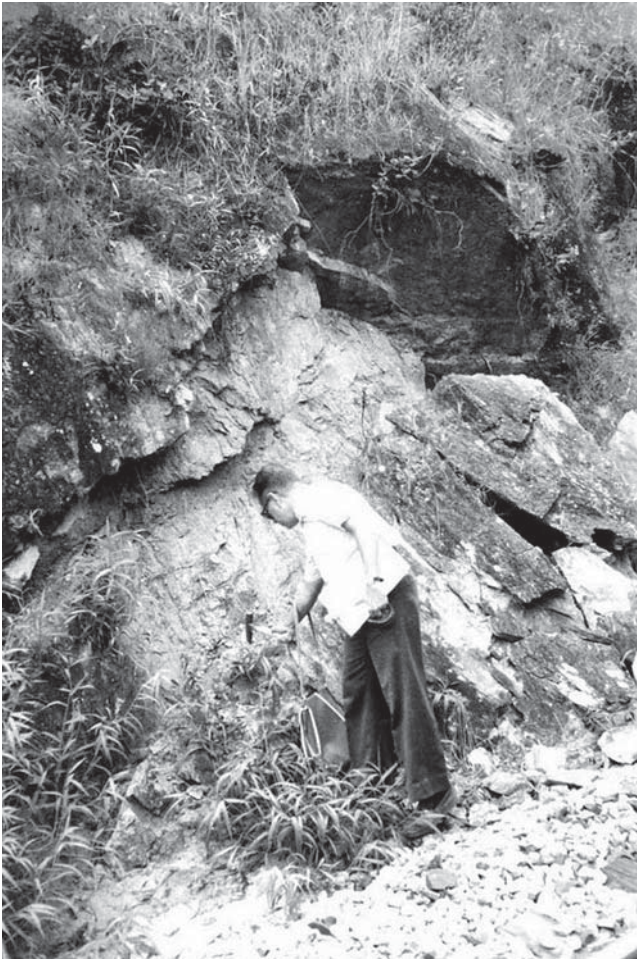
FIGURE 1.81

Same cut as in Figure 1.80, but at a different station. Wedge failure along dipping joints.

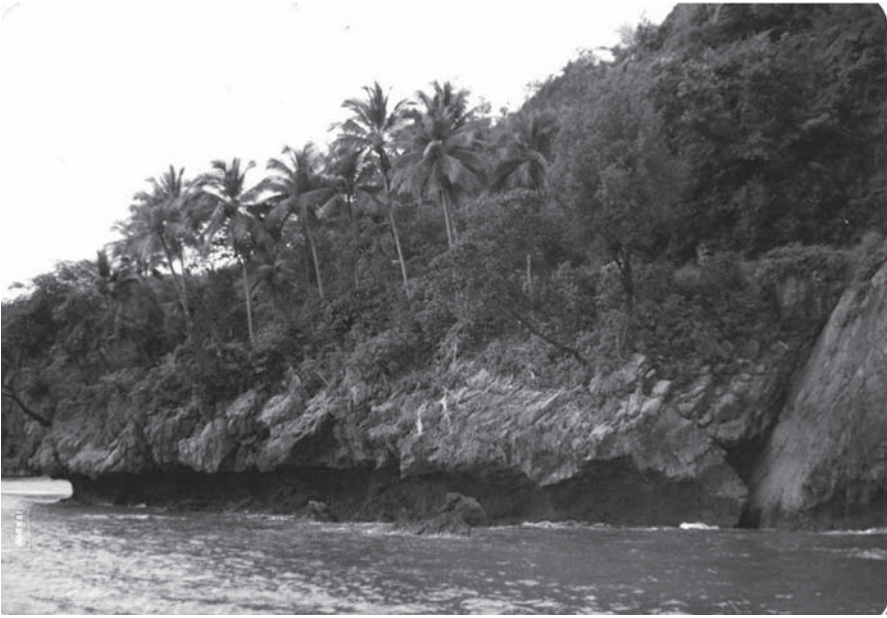
FIGURE 1.82

Sea erosion undercutting limestone and causing rockfalls. Slope failure could result in loss of roadway in photo middle (Tapaktuan, Sumatra) (see Figure 1.83 and Figure 1.84).

Sea erosion undercutting jointed limestone illustrated in Figure 1.82 was causing concern over the possible loss of the roadway, which is the only link between the town of Tapaktuan, Sumatra, and its airport. A fault zone may be seen on the right-hand side of the photo. For the most part, the joints are vertical and perpendicular to the cliff face, shown as plane *a* in Figure 1.83, and the conditions are consequently stable. Where the joints are parallel to the face and inclined into it, as shown by plane *b* in the figure, a potentially unstable condition exists. This condition was judged to prevail along a short stretch of road beginning to the

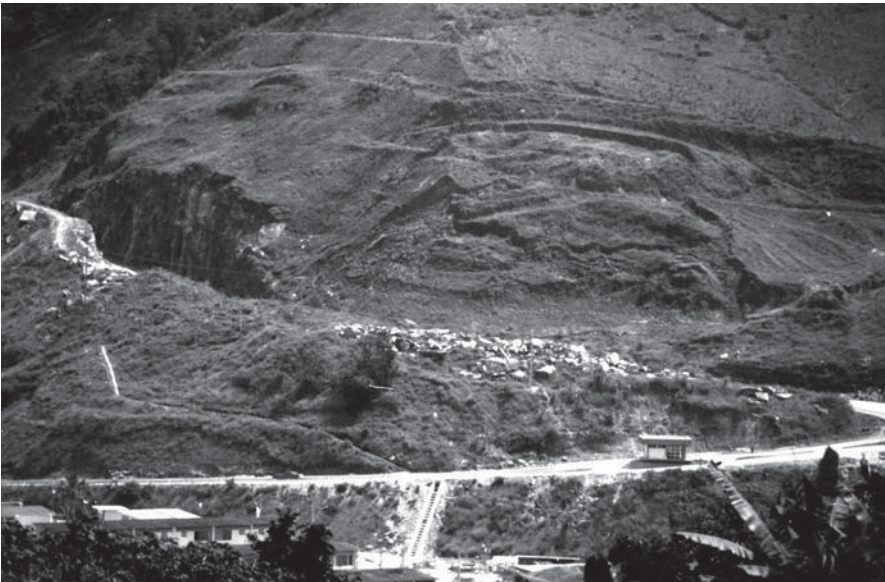
FIGURE 1.89

Slump movement caused by cut made in residual soils for the Rio-Santos Highway (Itaorna, Brazil) has remained stable as shown for at least 4 years. (Photo taken in 1978.) The slope form is convex. The failure shown in Figure 1.90 was located around the roadway bend in the photo (left).

Evidence that a slope is unstable requires an assessment of the imminence of total collapse, and, if movement is occurring, how much time is available for treatment and stabilization. Tension cracks, in particular, serve as an early warning of impending failure and are commonly associated with the early stages of many failures. Their appearance, even together with scarps, does not necessarily mean, however, that failure is imminent. The slope shown in Figure 1.89 appears precipitous but the slide has moved very little over a 4-year period, an interval of lower than normal rainfall (see Section 1.3.4). Note the “nose” location; a massive slide has already occurred along the slope at the far left in the photo that closed the highway for a brief time. This “total failure,” shown in Figure 1.90, occurred where the slope shape was concave, a few hundred meters from the slope in Figure 1.89.

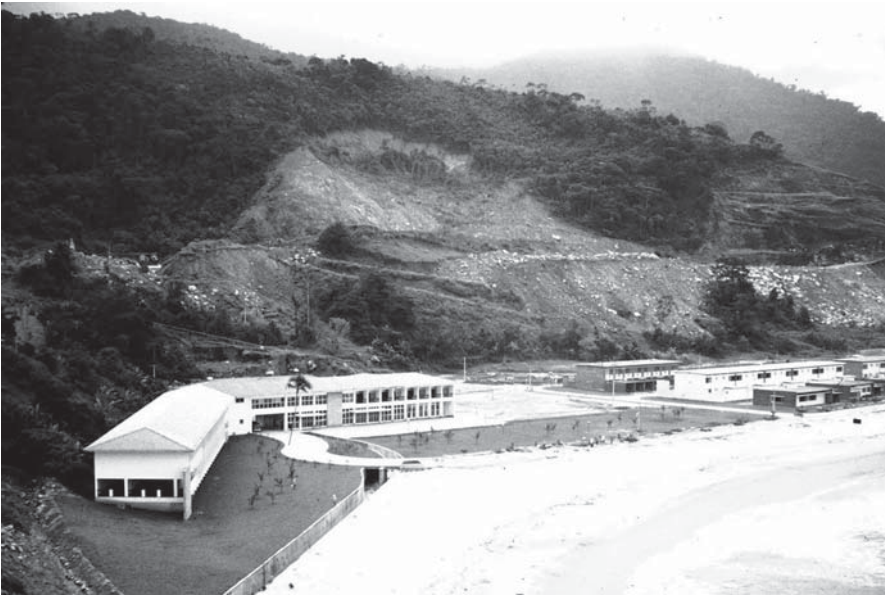
FIGURE 1.90
Debris avalanche scar along the Rio-Santos Highway at Praia Brava, Itaorna, Brazil. The slope form was concave; location is around the bend from Figure 1.89.

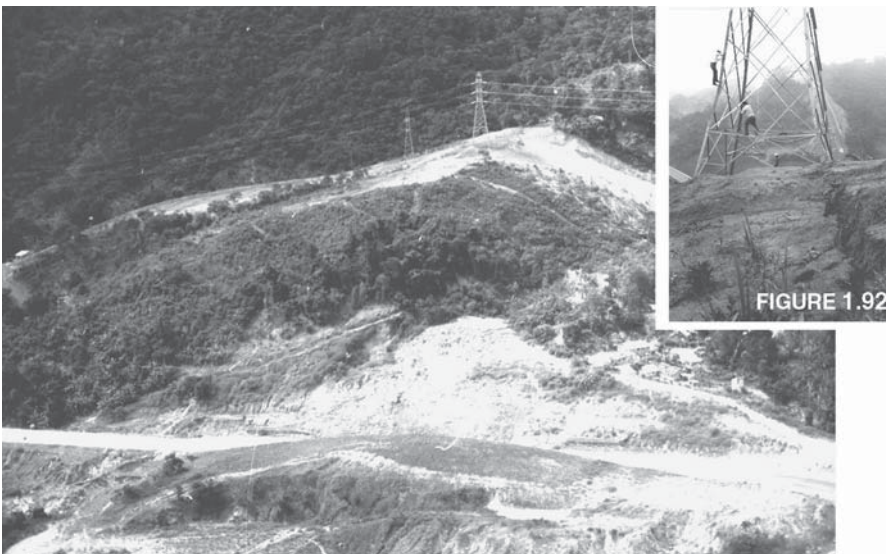
FIGURE 1.91

Rotational slide at Muriqui, Rio de Janeiro, Brazil, initiated by the road cut, had been active for 4 years. Major movements began after a weekend of heavy rains, endangering the transmission tower. Tension crack and distorted transmission tower shown in the inset, Figure 1.92.

Case 1: A roadway cut made in residual soils in the coastal mountains of Brazil continued to show instability through creep, tension cracks, small slumps, and periodic encroachment on the roadway for a period of several years. An intermediate failure stage occurred on November 29, 1977, after a weekend of moderately heavy rain and a period during which the highway department had been removing material from the slope toe. Figure 1.91, a photo taken from a helicopter about 10 days after the failure, illustrates the general conditions. Tension cracks have opened at the base of the forward transmission tower, a large scarp has formed at midslope, and the small gabion wall at the toe has failed.

Figure 1.92 illustrates the tension crack and the distortion in the transmission tower shown in Figure 1.91. The maximum crack width was about 30 cm (12 in.) and the scarp was as high as 50 cm (20 in.). Slope movement measurements were begun immediately by optical survey and the transmission lines were quickly transferred to a newly constructed tower situated farther upslope.

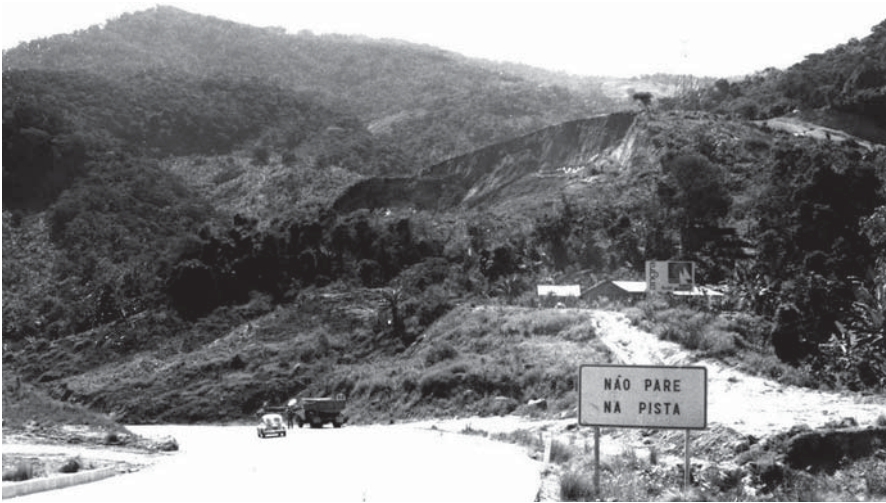
FIGURE 1.93

Total collapse of slope shown in Figure 1.91 left a high head scarp and temporarily closed the roadway. Failure occurred 6 weeks later during the rainy season after several days of heavy rains.

Case 2: A number of examples have been given of slope failures along the Rio Santos Highway that passes through the coastal mountains of Brazil. Numerous cuts were made in the years 1974 and 1975 without retention, and a large number of relatively small slides and other failures have occurred. The solution to the problem adapted by the highway department, in most cases, is to allow the failures and subsequently clean up the roadway. As of 1980, except for short periods, during the slide illustrated in Figure 1.93, the road has remained in service.

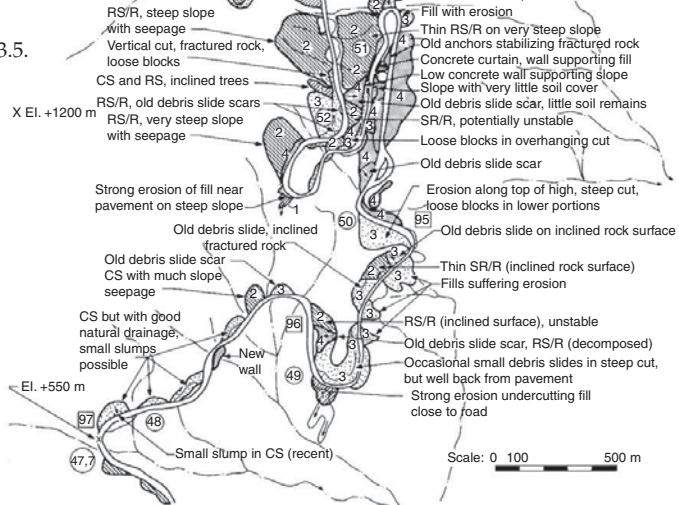
FIGURE 1.98

Slope failure hazard map for an existing roadway subject to numerous failures (BR-116, Rio de Janeiro, Brazil). A panorama of the road between km 52 and 53.5 is shown in the photo (Figure 1.97). A debris avalanche that occurred at km 56 is shown in Figure 1.10.

The map (Figure 1.98), prepared by the author during a 1979 study, illustrates the location of cuts and fills, drainage, and the degree of hazard. Maps accompanying the report gave geologic conditions and proposed solutions. The maps were prepared by enlarging relatively recent aerial photographs to a scale of 1:10,000 to serve as a base map for plotting, since more accurate maps illustrating the topography and locations of cuts and fills were not available.

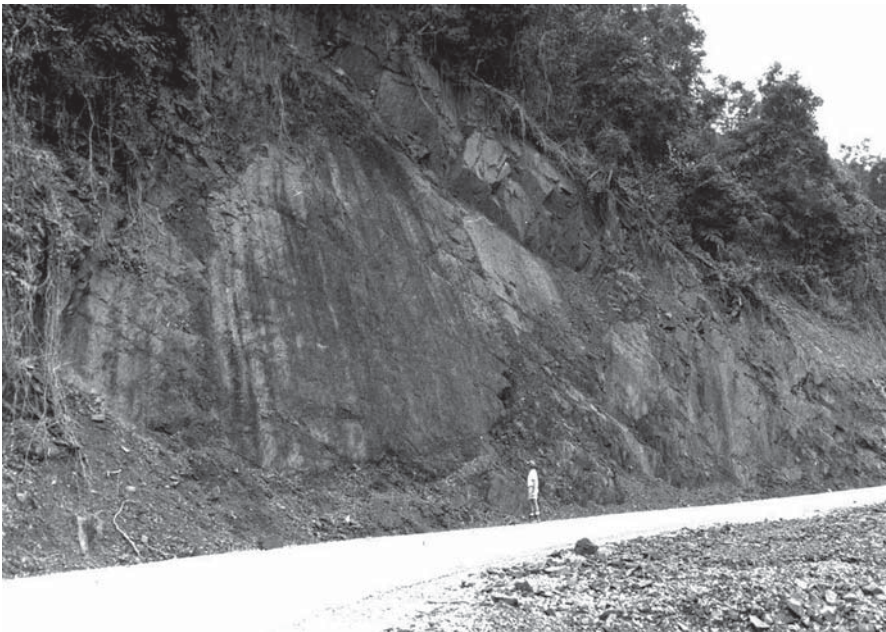
FIGURE 1.101
 The face of the major joint surface in siltstone is stable but the overhanging blocks will fail along the same surface unless removed or retained (Sidikalang, Sumatra).

Hard masses of igneous or metamorphic rocks, widely jointed, are commonly cut to 1H:4V (76°) as shown in Figure 1.100. Hard rock masses with joints, shears, or bedding representing major discontinuities and dipping downslope are excavated along the dip of the discontinuity as shown in Figure 1.101, although all material should be removed until the original slope is intercepted. If the dip is too shallow for economical excavation, slabs can be retained with rock bolts (see Section 1.4.6).

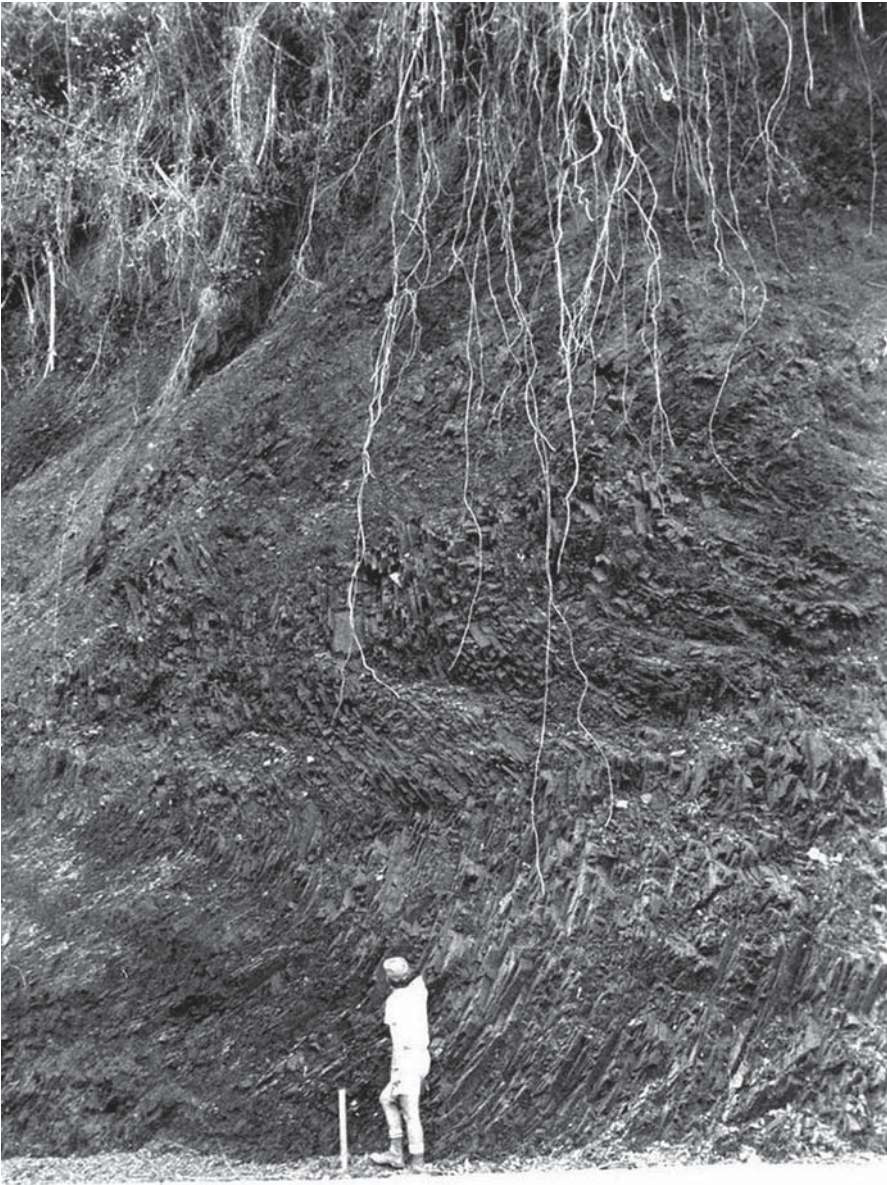
FIGURE 1.102

Folded, vertical beds in highly fractured, hard arenaceous shale are stable in near-vertical cuts (Sidikalang, Sumatra). Decreasing the slope inclination would increase susceptibility to erosion.

Hard sedimentary rocks with bedding dipping vertically and perpendicularly to the face as in Figure 1.102 or dipping into the face; or horizontally interbedded hard sandstone

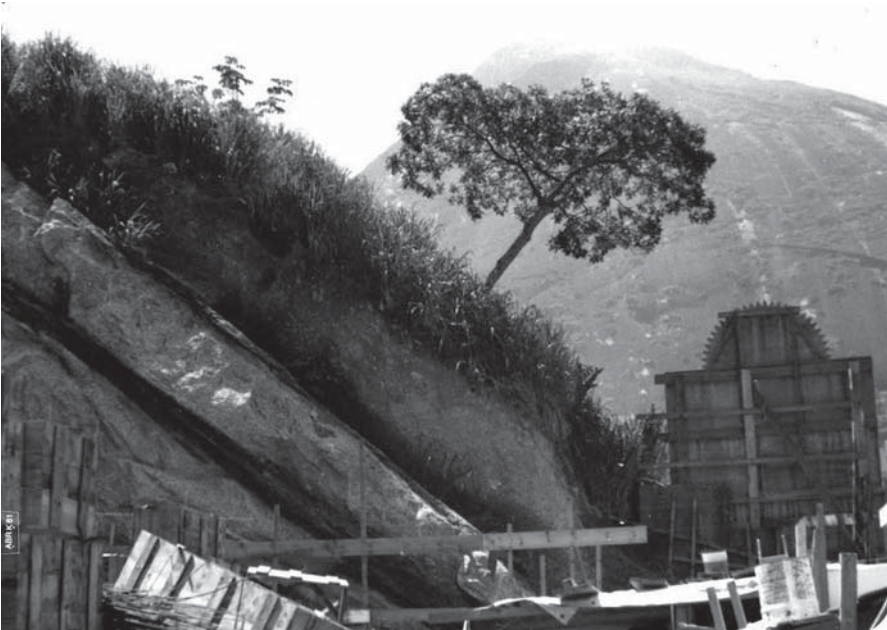
FIGURE 1.103

Cuts in colluvium over inclined rock are potentially highly unstable and require either removal of soil or retention (Rio de Janeiro, Brazil).

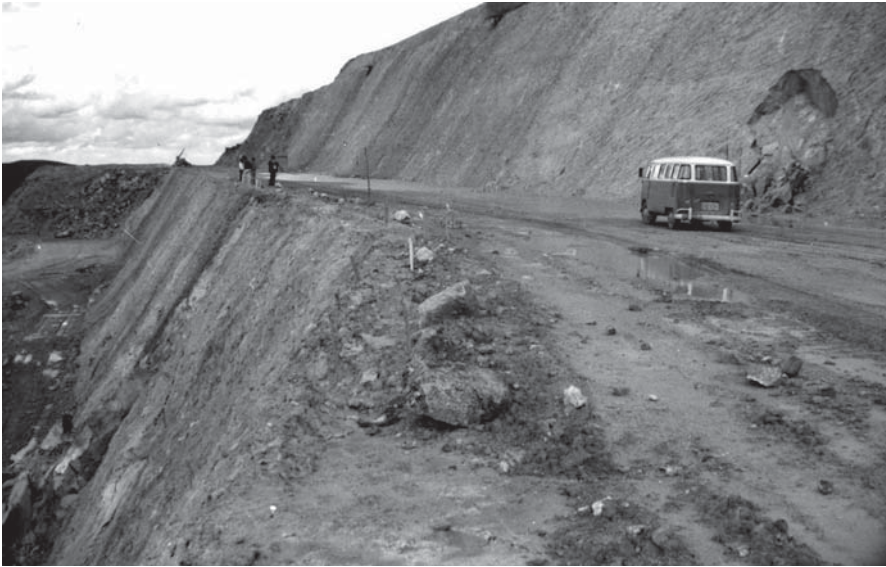
FIGURE 1.104

Cut slopes at the beginning of a 300-m-deep excavation in highly decomposed igneous and metamorphic rocks for a uranium mine. Bench width is 20 m, height is 16 m, and inclination is 1H:1.5V (57°). Small wedge failure at right occurred along kaolinite-filled vertical relict joint. Part of similar failure shows in lower left.

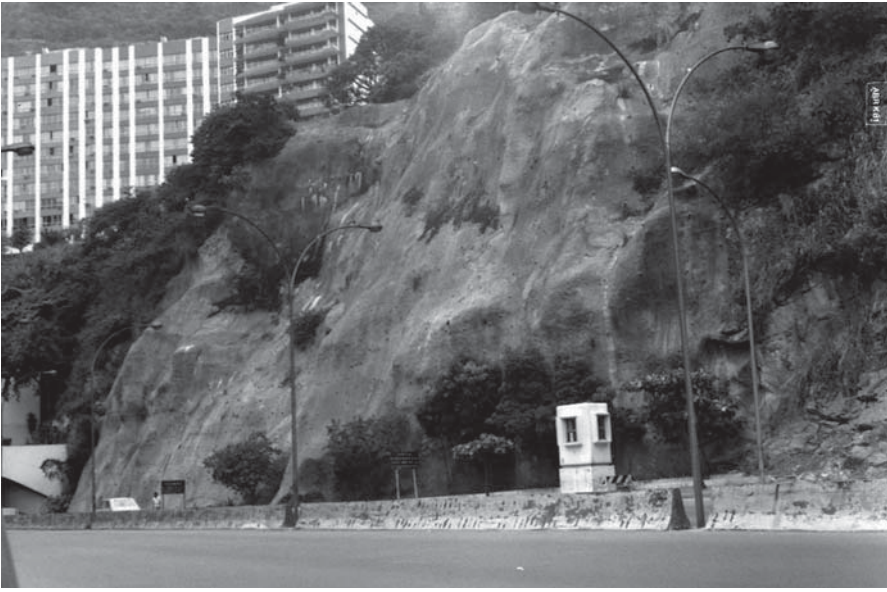
FIGURE 1.117

Shotcrete applied to retain loose blocks of granite gneiss in cut. Untreated rock exposed in lower right (Rio de Janeiro).

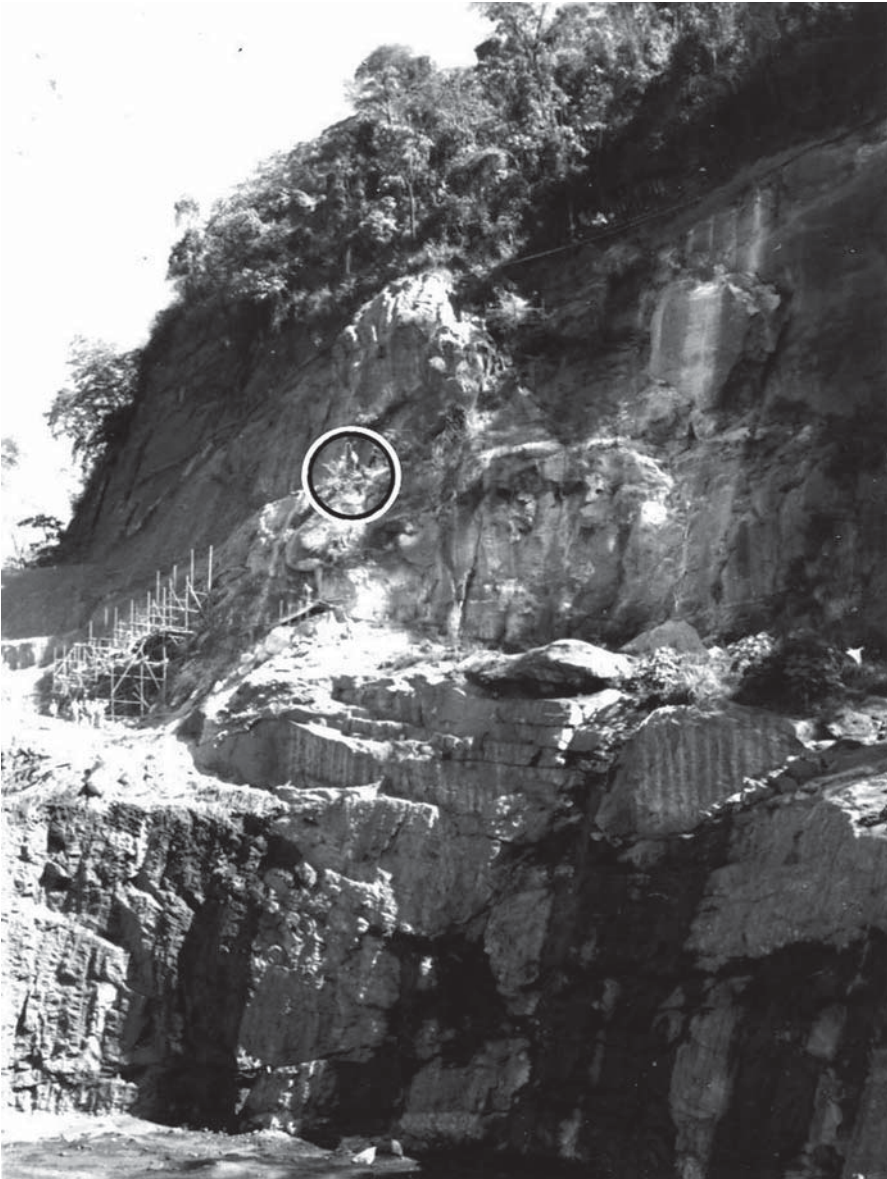
FIGURE 1.121

The 60-m-high slope of Figure 1.116 before treatment. The lower portions have been excavated into relatively sound gneiss. The workers (in circle) give the scale. Several large blocks weighing many tons broke loose during early phases when some scaling of loose blocks was undertaken.

A major installation of bolts and straps is illustrated in Figure 1.120, part of a 60-m-high rock slope (Figure 1.121), at the base of which is to be constructed a steel mill. The consultant selected the support system rather than shaving and blasting loose large blocks for fear of leaving a weaker slope in a high-risk situation.

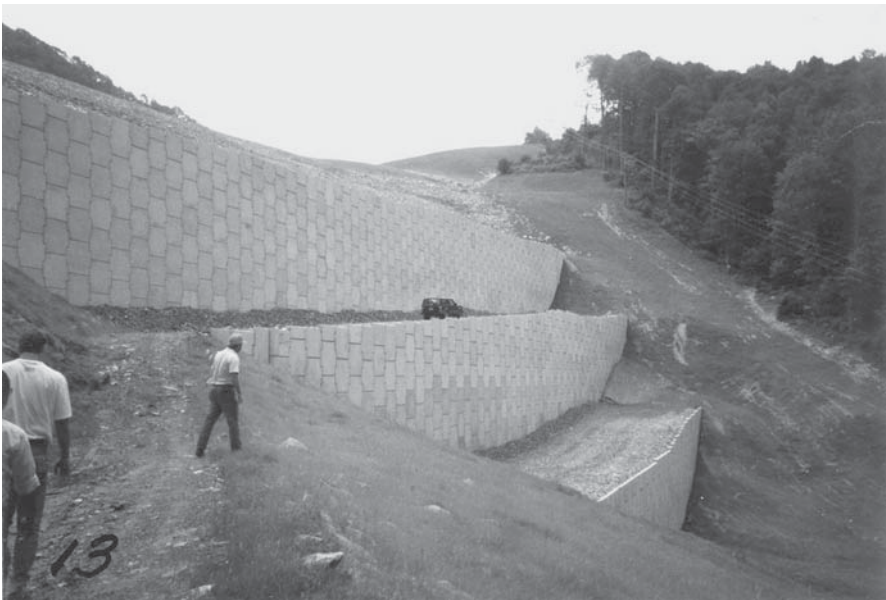
FIGURE 1.126

Reinforced earth walls over 100 ft in combined height support roadway fill, I-26, Sams Gap, Tennessee.

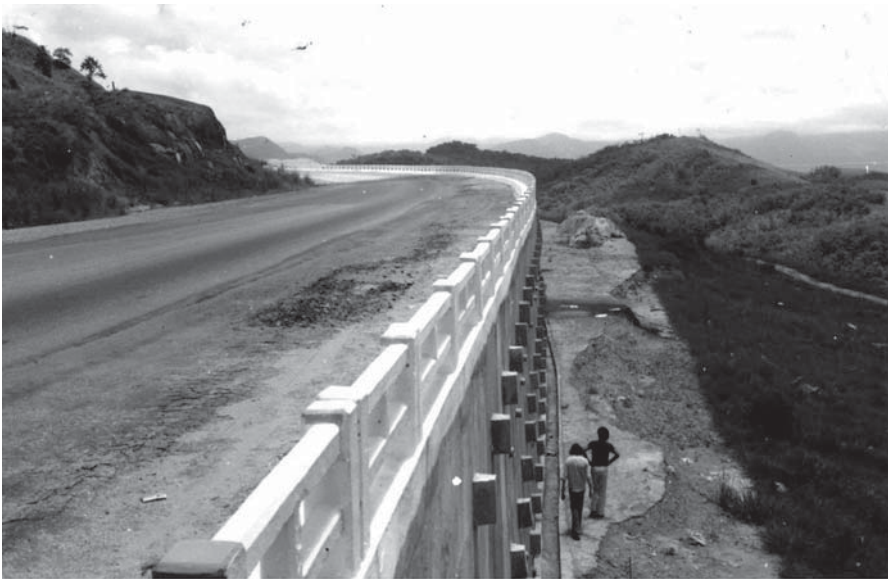
FIGURE 1.128

Anchored concrete curtain wall supports fill placed over colluvium. Wall is pile-supported to rock. Slope movements are occurring downslope to the right but the wall is stable (Highway BR 277, Parana, Brazil).

After the initial failure stage, subhorizontal drains may be adequate to stabilize the embankment if closely spaced, but they should be installed during the dry season since the use of water to drill holes during the wet season may accelerate total failure. An alternative is to retain the fill with an anchored curtain wall (see Figure 1.128).

Counterfort wall	A cantilever wall strengthened by the addition of counterforts.	Used for wall heights over 6 to 8 m.
Buttress wall	Similar to counterfort walls except that the vertical braces are placed on the face of the wall rather than on the backfill side.	As per cantilever and counterfort walls.
Anchored reinforced-concrete curtain wall	A thin wall of reinforced concrete is tied back with anchors to cause the slope and wall to act as a retaining system. A variation by Tecnosolo S. A. uses precast panels as shown in Figure 1.129.	Constructed in the slope from the top down in sections to provide continuous retention of the slope during construction. (All other walls require an excavation which remains open while the wall is erected.) Retention capacity is high and they have been used to support cuts in residual soils over 25 m in height. Drains are installed through the wall into the slope. <i>See also</i> Figure 1.127 and Figure 1.128.

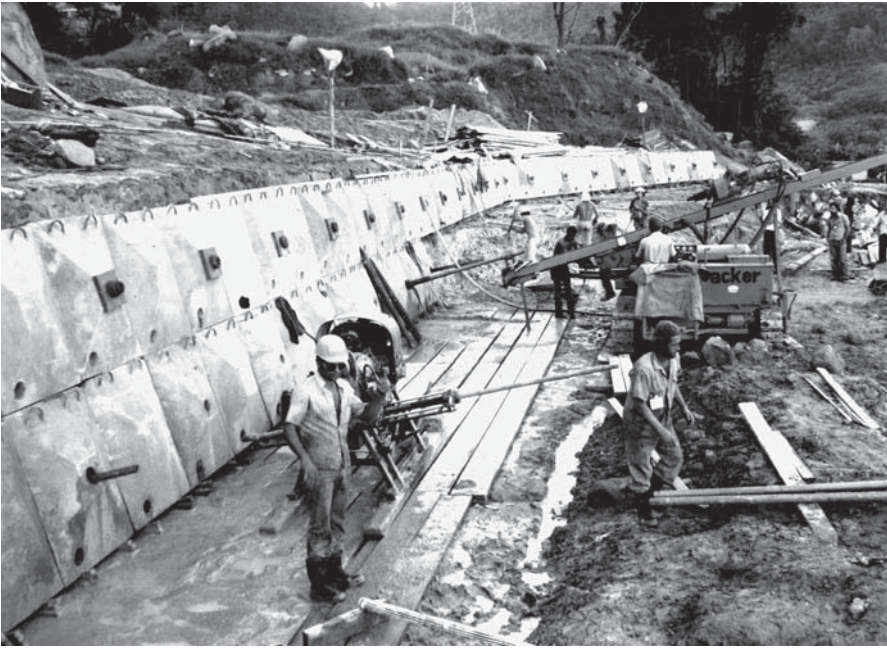
FIGURE 1.129

Stabilization of a slump slide with anchored premolded concrete panels which conform readily to the shape of the slope (Itaorna, R. J., Brazil).

Nongravity walls are restrained at the top and not free to move. They include basement walls, some bridge abutments, and anchored concrete curtain walls. *Anchored concrete curtain walls*, such as the one illustrated in Figure 1.127, can be constructed to substantial heights and have a very high retention capacity. They are constructed from the top down by excavation of a series of benches into the slope and formation of a section of wall, retained by anchors, in each bench along the slope. Since the slope is thus retained completely during the wall construction, the system is particularly suited to potentially unstable or unstable slopes. An example of an anchored curtain wall retaining a side-hill fill is shown in Figure 1.128. A variation of the anchored curtain wall consists of anchored pre-molded concrete panels. The advantage of the system is that the wall conforms readily to the slope configuration, as shown in Figure 1.129.

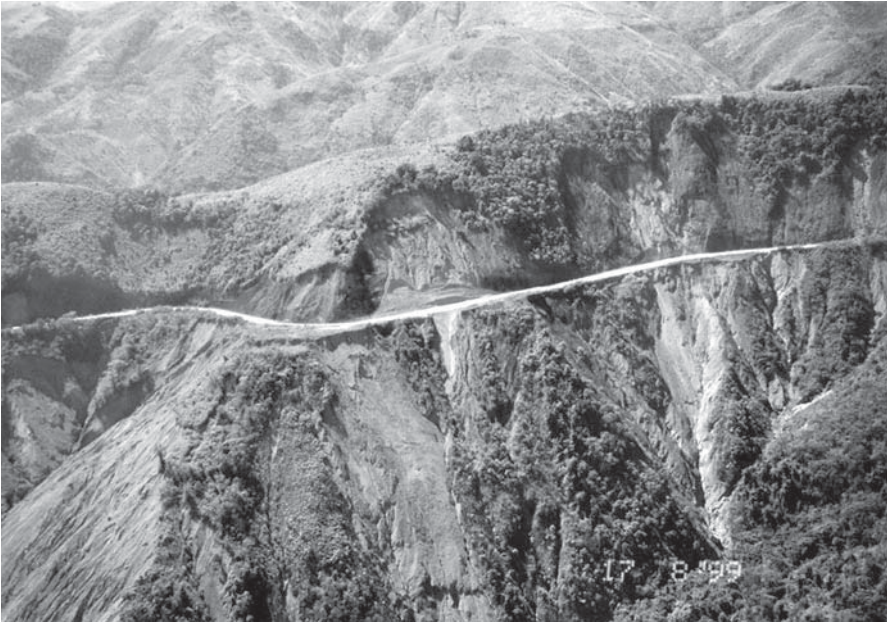
FIGURE 1.132

Debris avalanches, km 83 along roadway in Figure 1.131.

Initially, investigation included a number of trips along the roadway during which the slope failures were photographed and cataloged. Pairs of aerial photos were examined stereoscopically. Eventually a helicopter fly-over was made and the roadway continuously photographed. Debris avalanches, occurring on the upslope side of the roadway, were the most common form of slope failure (Figure 1.5 and Figure 1.132). More than 125 failure locations were identified. The landslide debris was bulldozed from the roadway onto the downslope side (Figure 1.132) further destabilizing the slopes and contributing to erosion and choking of streams downslope.

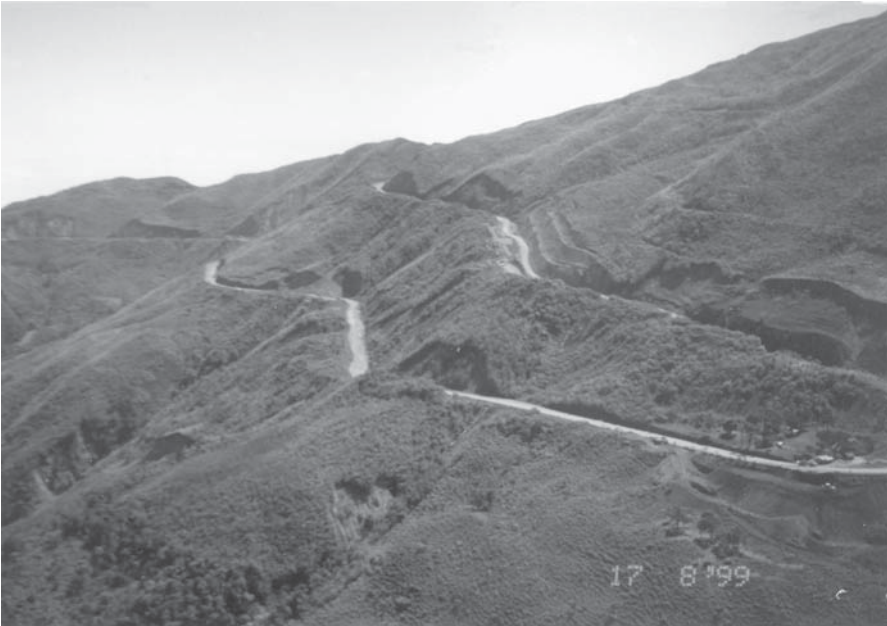
FIGURE 1.133

Large slump slide at km 75 located in Figure 1.131. Large tension cracks appeared upslope and the two roadways in the photo center have dropped several meters.

Other slope failures included a few large “slump” slides (Figure 1.133) and numerous failures on the downslope of the roadway resulting from erosion from discharge of roadway storm drains (Figure 1.6).

At km 75 the roadway makes an abrupt switch-back as shown in Figure 1.133. At this location is a large slump slide evidenced by tension cracks upslope and roadway movement. When first visited during 1999 the portion of the roadway in the middle of the photo (Figure 1.133) had dropped about 2 m; when visited the following year, the roadway had dropped an additional 2 m and was almost impassable. This was considered a priority site for remediation.
